**Contribuții privind evaluarea biofuncționalității endoprotezelor de șoldmetal-metal tip BHR**

**Contributions on the evaluation of the biofunctionality of metal-metal hip endoprotheses type BHR**

## **Chapter 5. Analysis of Causes of Failure for Birmingham Hip Resurfacing (BHR) Hip Resurfacing Hip Endoprostheses Based on Investigation of Prosthetic Explants**

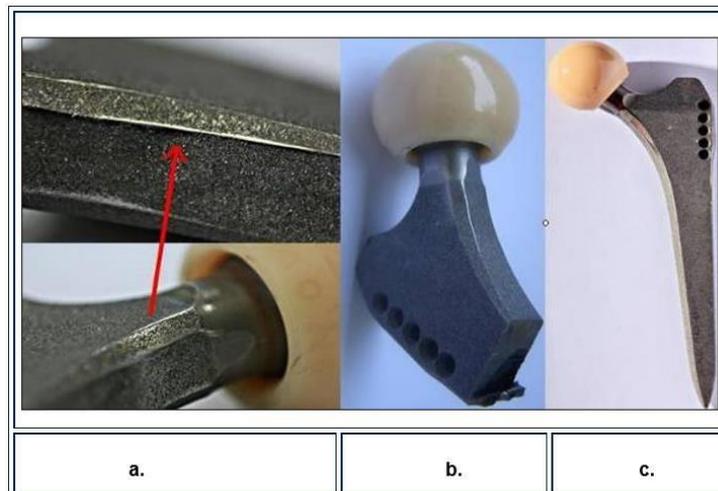
Wear areas are visible in the places with maximum load, located on the aluminium head and in the head-to-tail interface area. The deposition of porous titanium was affected in certain regions, especially in the neck area and partially in the tail. The prosthesis showed adequate stability, and no significant defects were identified.

Figure 33. Macroscopic aspects of the explant: a. Obvious wear on the neck and tail of the prosthesis b. The appearance of the prosthesis after the cutting process c. Condition of the prosthesis after explantation

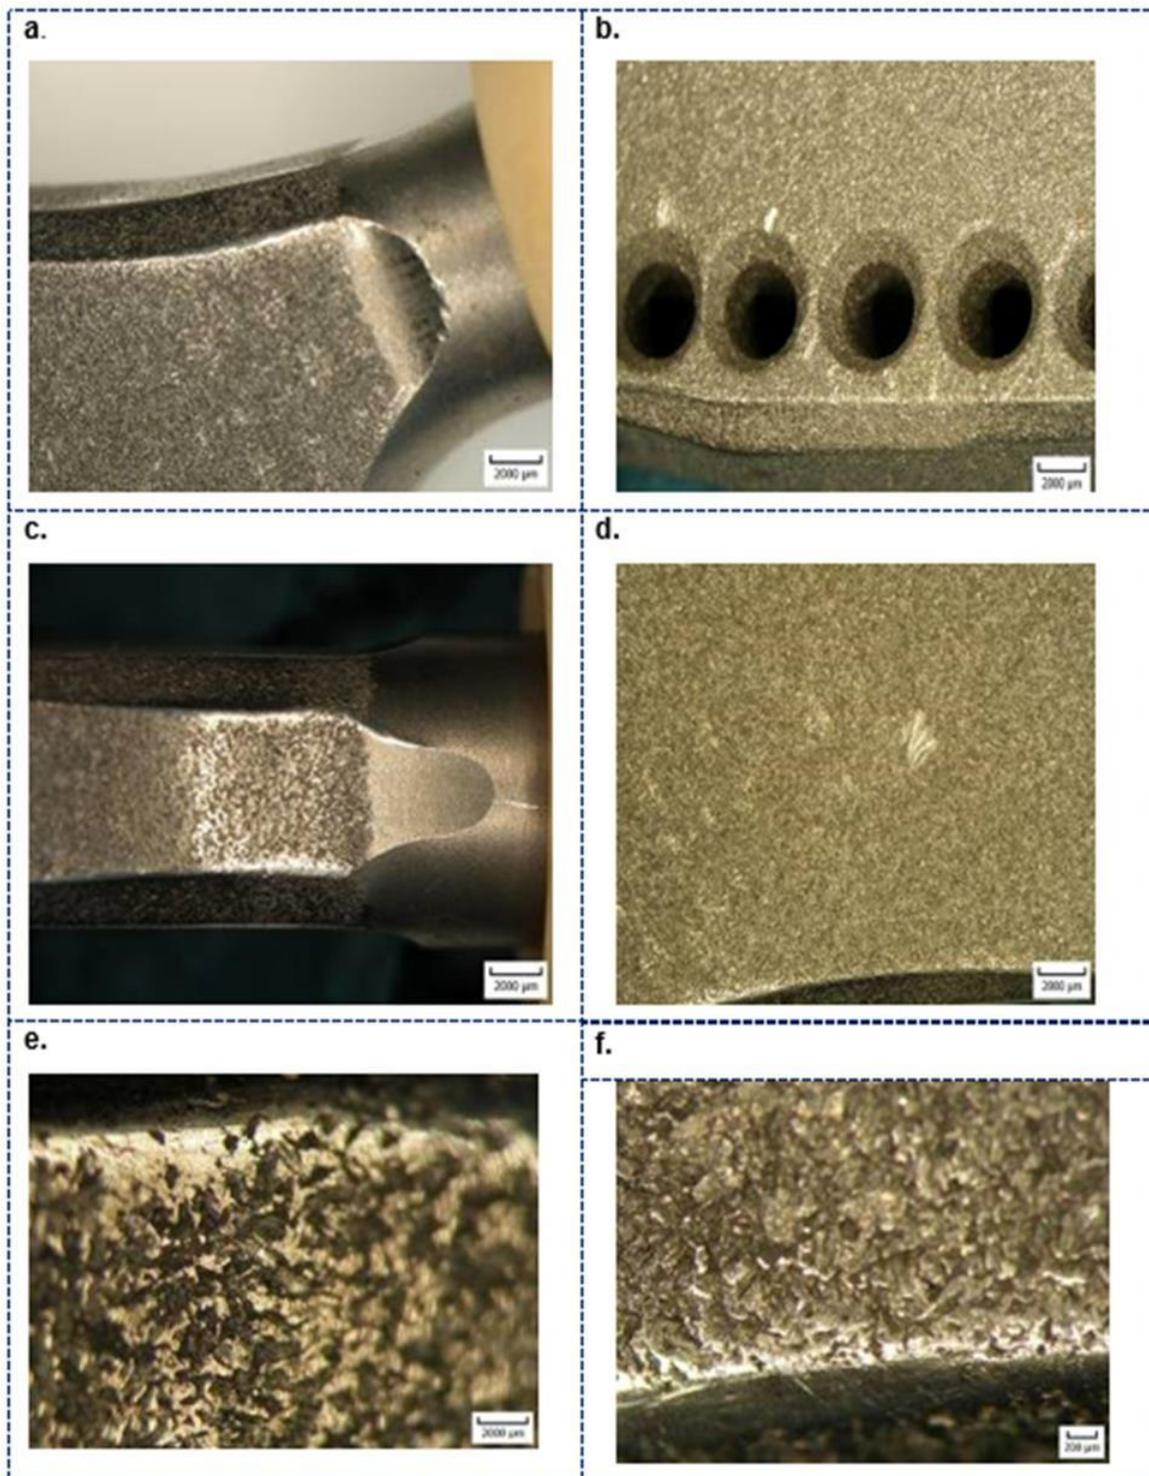
Figure 34. Stereomicroscopic images: a. Wear at the head-tail interface, increased by 8 times; b. Areas of porous titanium affected by wear, enlarged by 8 times; c. Areas more severely affected by wear, enlarged 8 times; d. Detail of the prosthesis tail surface, magnified by 8 times; e. Detail in the neck area of the prosthesis, enlarged by 50 times; f. Detail of the tail of the prosthesis, with porous titanium deposits affected by wear, magnified by 50 times.

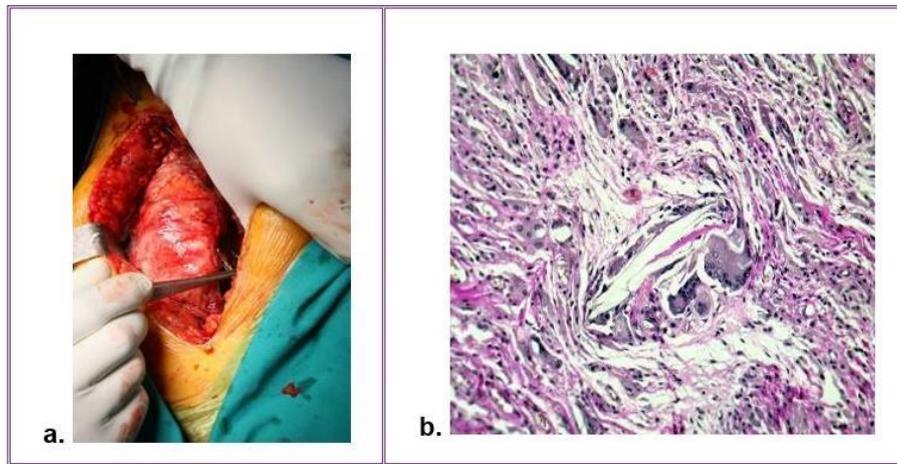
Figure 35. a. Tissue sampling for histopathological investigations during surgery. b. Optical microscopy of the tissue investigated in case II (foreign body reaction with crystalline inclusion, HE is staining, 20x magnification)

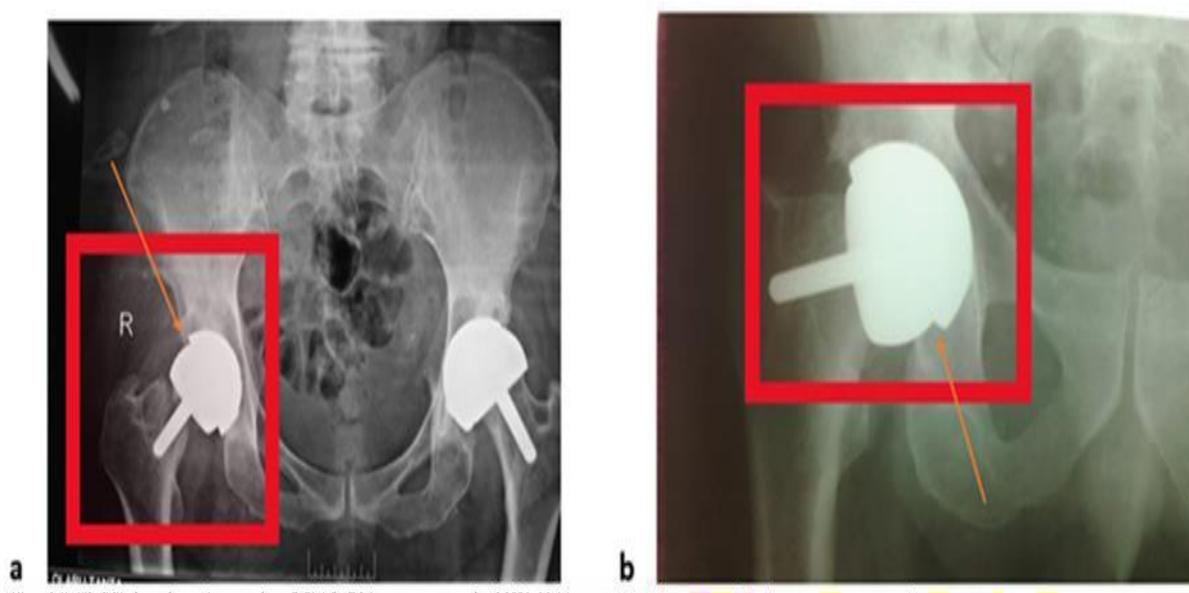
Figure 49 corresponding to the first case in the series of BHR implant failures, analysed, illustrates the wear induced by the marginal load due to the excessively vertical positioning of the acetabular cavity. In image B, the degree of inclination is even more pronounced, resulting in progressively more severe wear.

*Figure 50. X-rays of acetabular component failure: Edge loading at different degrees of loading* <sup>14</sup>

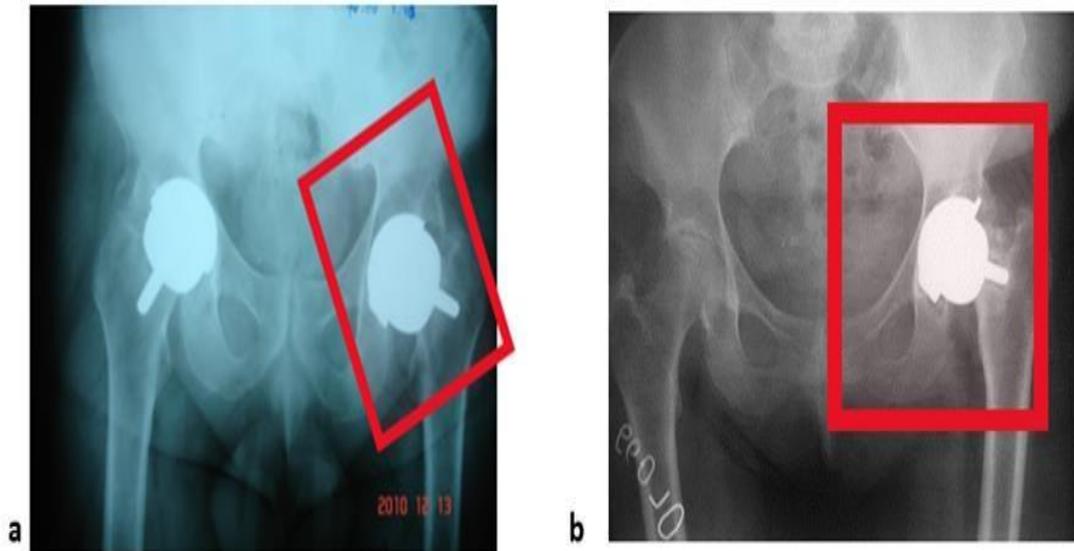
Also, improper positioning of the femoral component can lead to imbalance, asymmetrical wear and the risk of bone fracture. As can be seen in the second case of this series from the radiographs in Figure 50 (a, b), a wrong positioning angle caused the displacement of the femoral component and the dislocation of the prosthesis from the integration area.

*Figure 51. X-rays of femoral component failure: analysis of the consequences of inadequate positioning* <sup>15</sup>

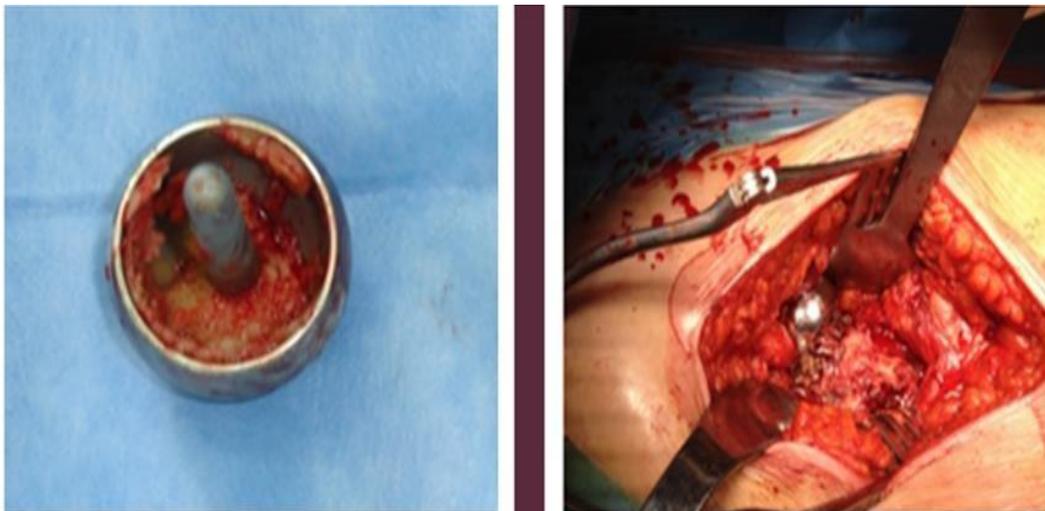
The analysis of the intraoperative images performed for this patient reveals that, despite an apparent good integration between the prosthesis and the bone, incorrect positioning remains a recurring problem, highlighting the need for increased attention and expertise in the implantation process to minimize risks and maximize the success of orthopaedic surgeries.

*Figure 52. Intraoperative Images: Monitoring of Bone Integration and Adjustment of Prosthesis Position* <sup>16</sup>

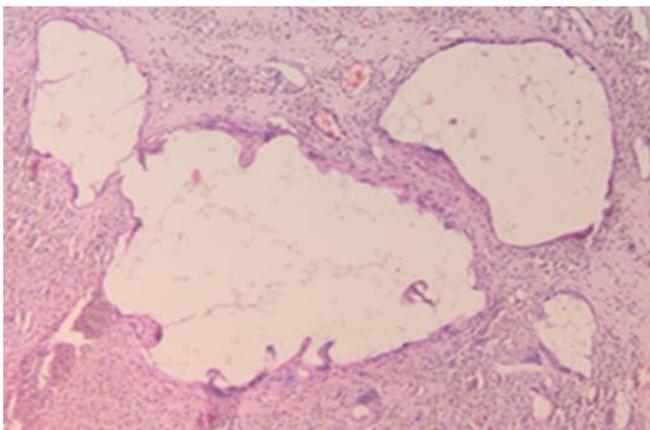
**a.** Granulomatous inflammatory foreign body reaction, characterized by the presence of multinucleated giant cells grouped around pseudo cystic spaces containing fine granular material (radiopaque material from prosthetic cement), accompanied by accumulations of macrophages with fine foamy and granular cytoplasm. (HE x100).

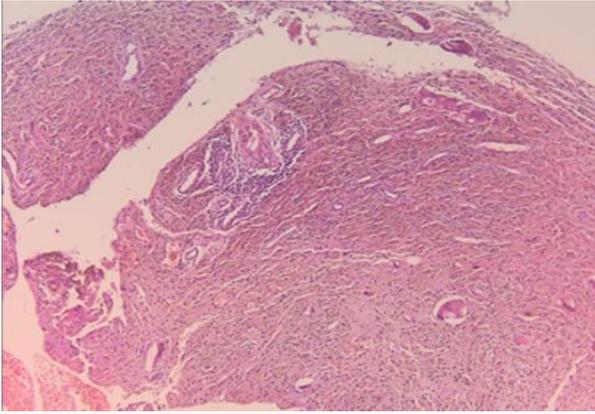
<p><b>b.</b> Perivascular lymphocytic infiltrate located at the top of the image. (HE x100).</p>

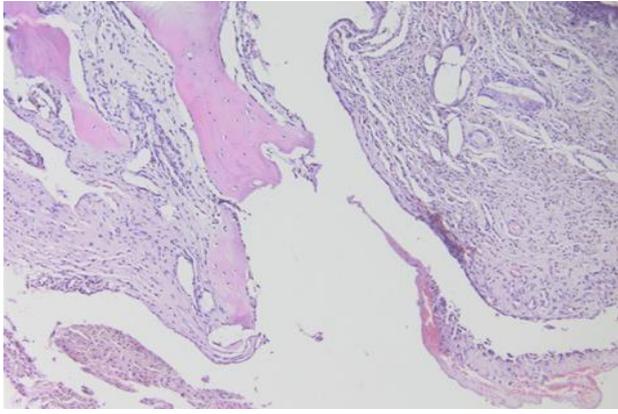
<p><b>c.</b> Mature spongy bone tissue showing intertrabecular fibrosis and, on the right side of the image, a granulomatous foreign body inflammatory reaction surrounding small pseudo cystic spaces. They are associated with groups of macrophages having cytoplasm containing a fine, granular pigment of yellow-brown color. (HE x100).</p>

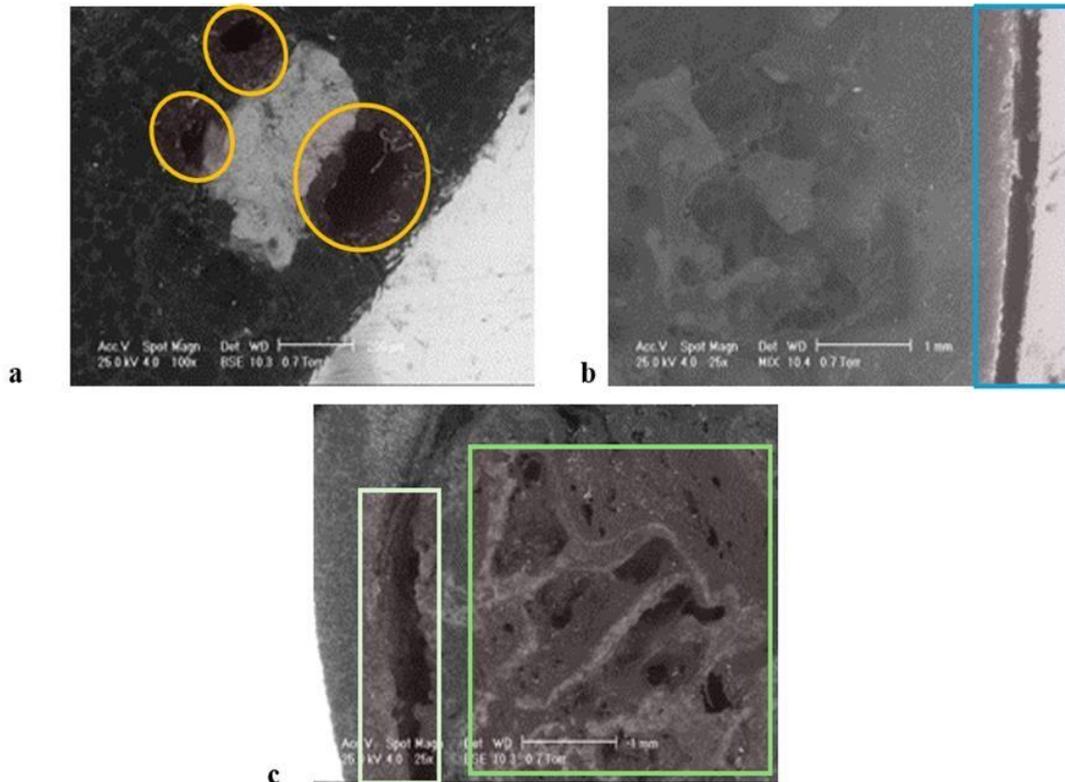
Figure 64. SEM Analysis of Structural Defects Caused by Improper Cement Application Technique

In the analyzed samples, various problems were identified that led to the failure of BHR implants. In Figure 64a, it can be seen that the mixing technique used for the preparation of acrylic cement was not efficient, with air bubbles in the final material being highlighted. Also, the viscosity obtained was not suitable for a uniform application, which resulted in an uneven distribution of the cement mantle, although the measurements indicated values close to the required standard dimensions. In Figure 64b, a large air gap between the cement mantle and the bone is visible, which prevented the formation of a proper cement-bone interface. In Figure 64c, the lack of cement-bone interface is highlighted, caused by the incorrect application of cement, and an advanced state of bone necrosis is observed compared to previous cases; The cement penetrated the bone unevenly due to inadequate viscosity.

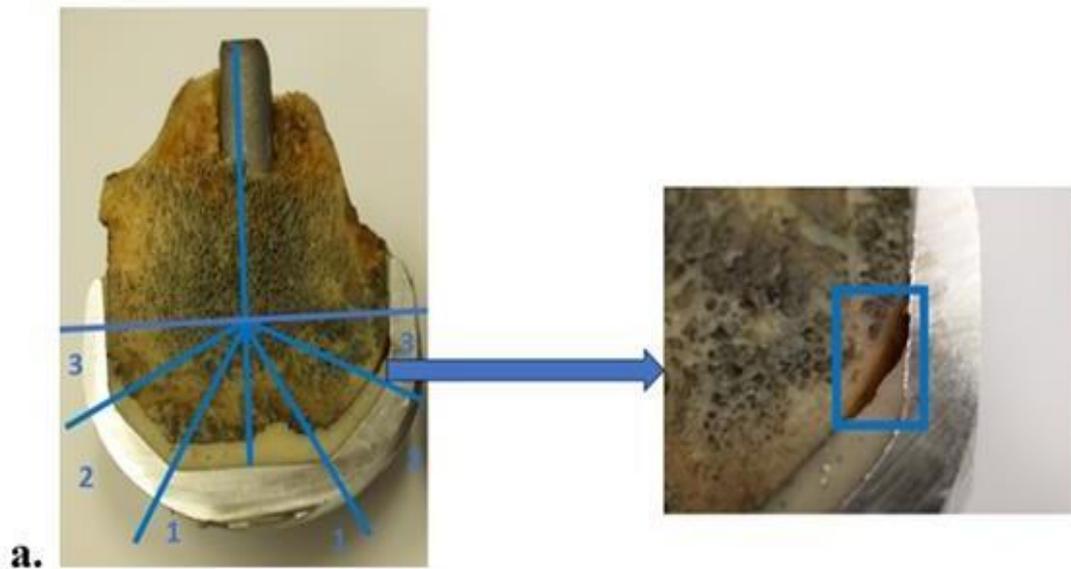
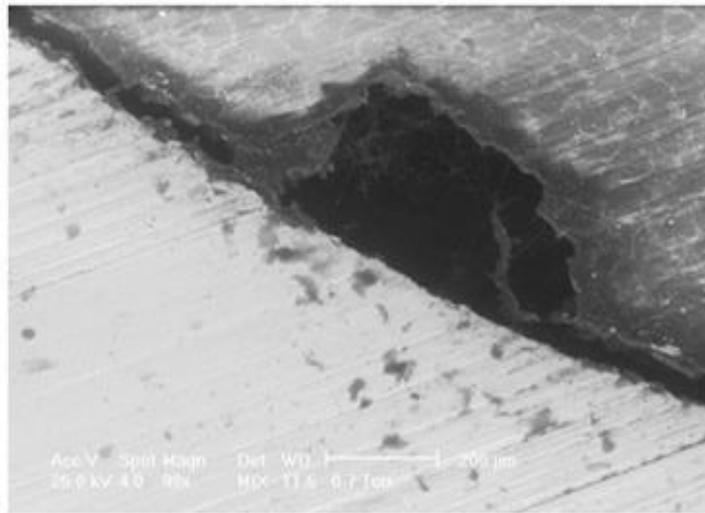
*Figure 66. a. Weak interface indicates cementation defect, b. SEM micrograph of cement in sample 5 highlights cracks* <sup>20</sup>

Figure 66 shows poor bonding both between the cement and the denture surface and between the cement and the adjacent bone. In zone 3, the formation of an air gap between the cement sheath and the bone is noted, which prevents the formation of a proper interface between the cement and the bone. Dark, porous areas indicate the presence of necrotic bone, while lighter areas show how cement has penetrated the bone structure. The poor interface can be caused by an incorrect cement mixture or contamination with moisture or other foreign substances during application. The main problem exposed in the case of this prosthesis is the weakening of the fixation of the prosthesis, followed by displacement and degradation over time.

In Figure 66 b, the SEM analysis reveals a problem because the human bone comes into direct contact with the metal part of the acetabular cup. Also, the lack of cement-bone interface is observed due to the space formed by improper cement application. A significant deficiency is highlighted due to insufficient filling of the acetabular cup with bone cement.

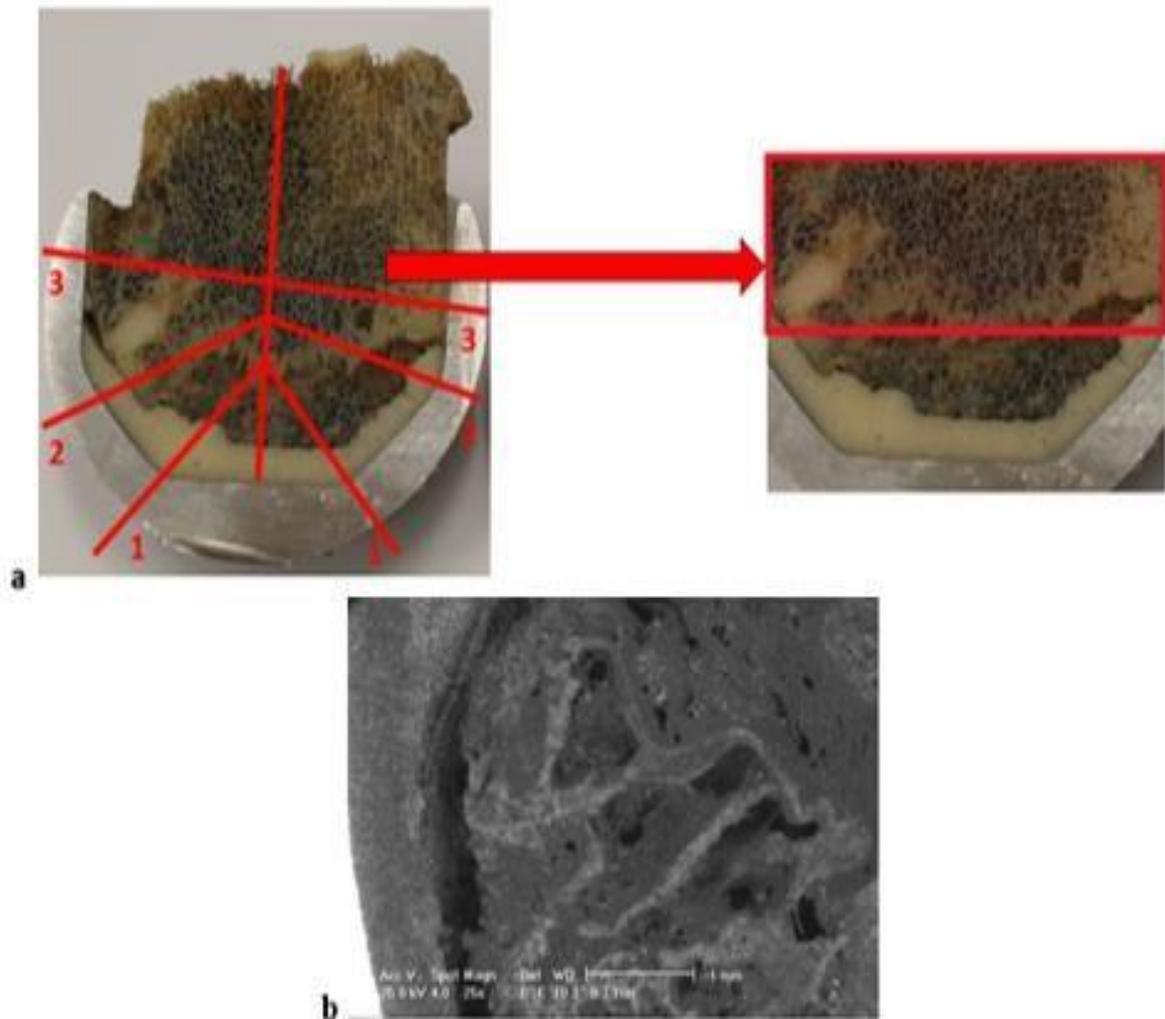
Figure 67. BHR prosthesis explanation: Cementation deficiency evidenced by uneven texture (a. Macroscopic analyses and b. SEM analyses)

Sample 3, shown in Figure 67, shows a much more advanced state of bone necrosis compared to previous cases, both at the macroscopic level and following the SEM analysis. The dimensions of the cement mantle do not comply with the necessary standards and its application is not uniform. The cement penetrates the bone without following clear rules, resulting in a distance between the cement mantle and the bone. Detailing the image, a crack was observed that had started from the space formed in the cement mantle and extended to the edges of the acetabular capsule.

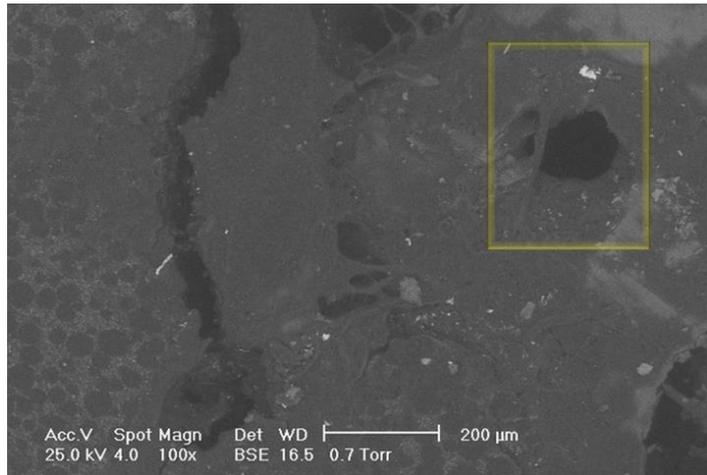
We identified a few significant issues during the analyzes performed. One of these was the presence of air bubbles in the cement mantle, resulting from the inadequate mixing of cement, affecting its integrity. We have also noticed an uneven thickness of the cement mantle, caused by incorrect cement application or uneven pressure exerted during the cementing procedure. Another major problem was the poor interface between cement and bone, caused by incomplete cleaning of the femoral canal prior to cement application, allowing tissue materials to interfere with the proper adhesion of cement to the bone. To highlight these shortcomings – air bubbles, unevenness and poor interface – we performed further analyses using scanning electron microscopy (SEM).

Figure 68. SEM analysis of air bubbles of varying sizes that have arisen in the cement mantle because of a defective procedure. <sup>22</sup>

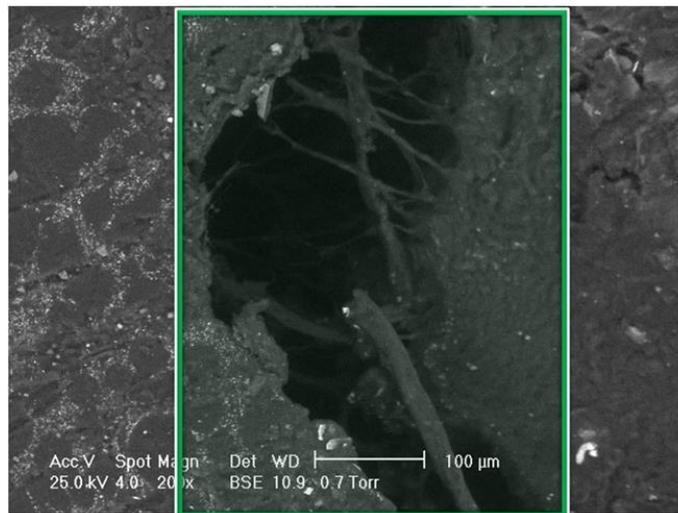
Figure 69. BHR prosthesis explanation: The cementation problem illustrated by the poor interface between bone cement and metal component. <sup>23</sup>

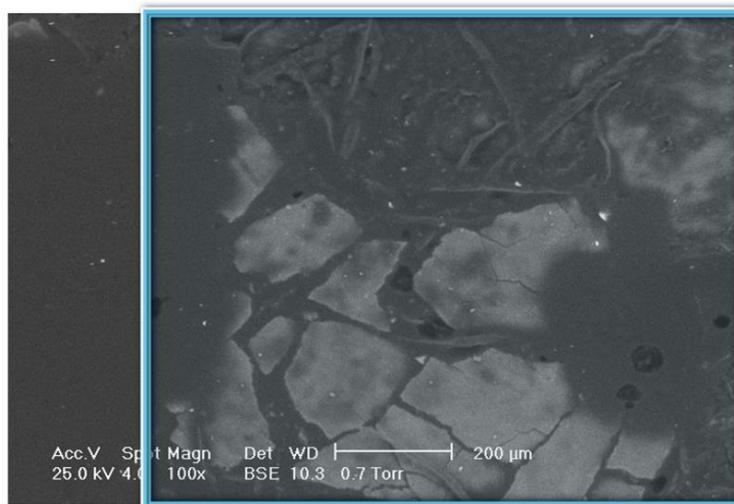
Figure 70. BHR Denture Removal: Cementation Defect Evidenced by Uneven Texture
