”POLITEHNICA” UNIVERSITY OF BUCHAREST
FACULTY OF INDUSTRIAL ENGINEERING AND ROBOTICS

PhD THESIS SUMMARY

OPTIMIZATION OF REPAIR-BY-WELDING TECHNOLOGIES ON LOW-ACCESS JOINTS

Author: Eng. Florina IONESCU

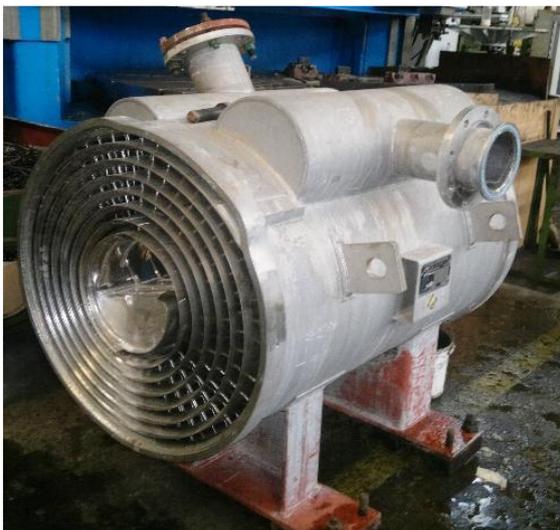
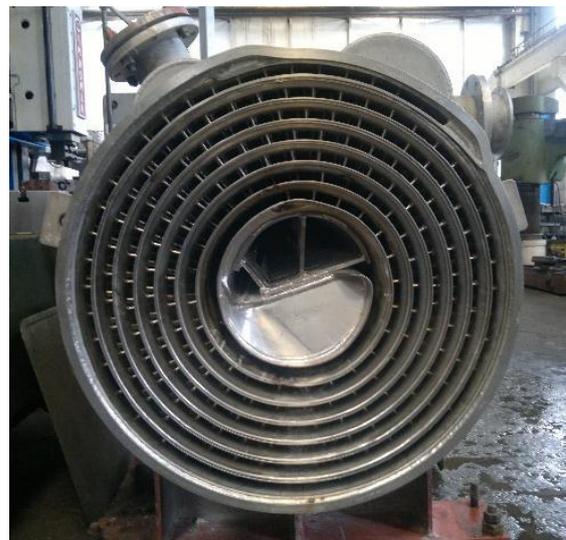
Figure 2.3. Spiral heat exchanger having defects along the entire width of the spirals, towards the center of the exchanger [30] a), b) overview of the spiral heat exchanger;
 c) bare spiral; d), e) the waves / valleys created around the spacers - on the inside;
 f) waves / valleys created around the spacers - on the outside;

Usually, most defects are located on the sheets (spirals) towards the center of the exchanger, where the peripheral speed increases greatly, due to the smaller diameter of the turn. The starting spire has a diameter of about 1 m and the final one is 0.3 m, which means a nearly 3-fold increase in the peripheral flow velocity with major implications on the cavitation phenomenon [15, 21, 30, 41].

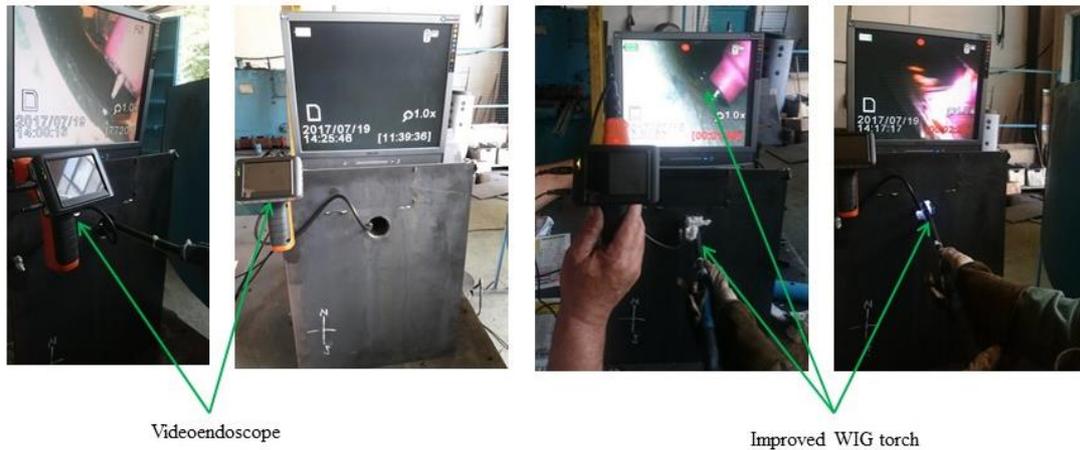
Figure 4.2. Experimental welding equipment built [29]

Figure 4.2 shows the experimental equipment made.

The design and construction of such flexible welding equipment, having very small dimensions, less than 25 mm in any direction raised several technical issues that had to be taken into account [29]:

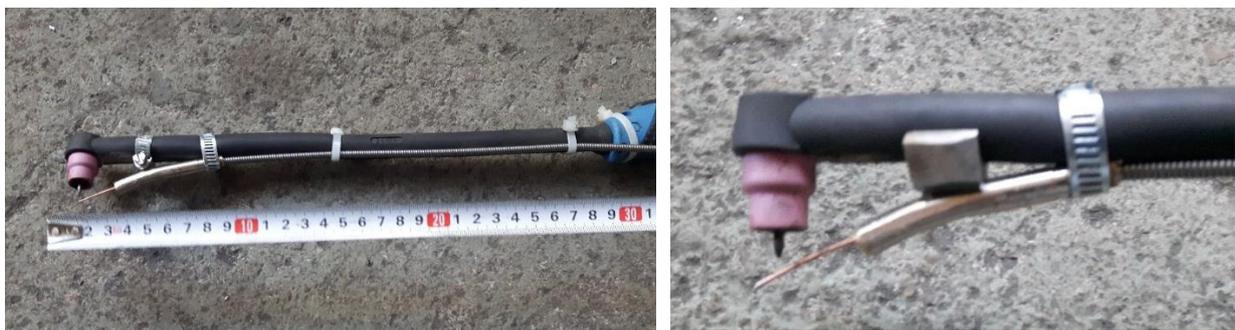
The WIG welding torch used was modified in the sense that it was added to the part of the welding wire feed - roller. The welding wire comes next to the tungsten electrode through a metal guide tube. The guide tube was attached to the body of the welding torch and its neck to form a common body. The wire is driven out of the tube through a contact nozzle, see figure 4.4. [99, 101].

Figure 4. 4. WIG torch used.

1) The control of the two subassemblies, torch and welding wire feed-roller is done separately. The torch can initiate the electric arc and, if necessary, the pedal can start and stop welding wire feed-roller.

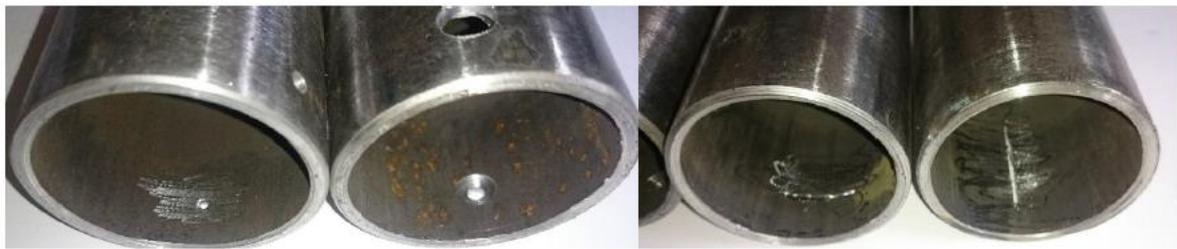
Figure 4. 5. Pipe-type products with artificially created defects

Welding tests were carried out using different type of semi-finished product and repaired mechanical processed defects in a pipe, defects that may occur in operation, pores, holes, cracks; repair of defects in pipes by welding was using the improved torch and the new laparoscopic welding technology- figure 4.5 and 4.6. These tests were performed in order to accustom the operator to the new type of torch. All welding tests were performed by inserting the torch into the pipe and monitoring the molten pool using video endoscope.

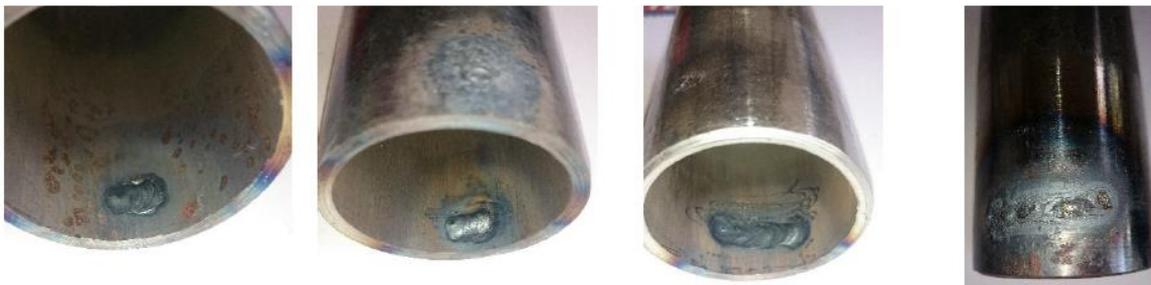
Figure 4. 6. Pipe type samples repaired by welding

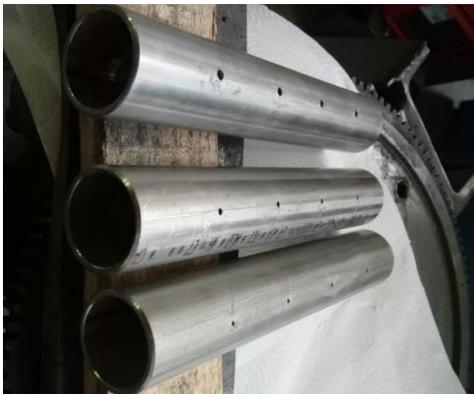
Figure 5.1. Austenitic stainless steel pipe X2CrNiMo17-12-2, 1÷3 samples [31, 33]

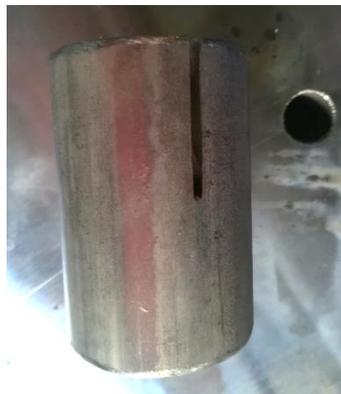
Figure 5.2. Austenitic stainless steel pipe X2CrNiMo17-12-2, sample 4 [31]

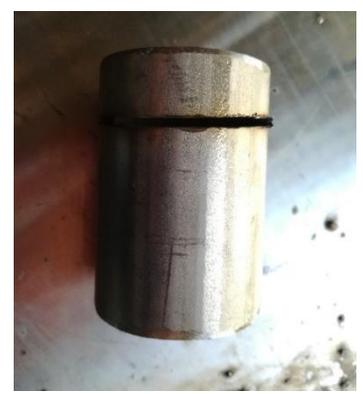
Figure 5.3. Austenitic stainless steel pipe X2CrNiMo17-12-2, sample 5 [31]

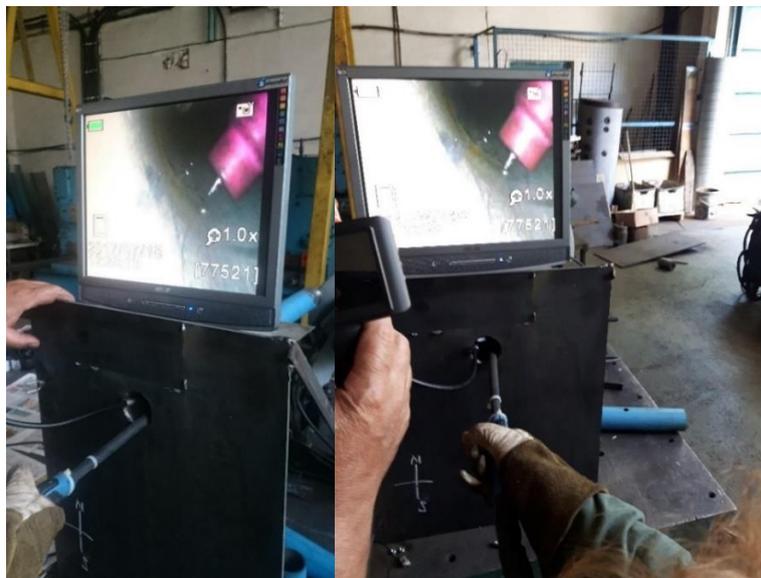
The samples were fixed in the experimental stand and repaired by welding. ESAB - Origo Tig 3000i AC / DC equipment was used to perform the tests. It allows the formation of the welding arc starting with 5 A - 300 A. The samples repair took place using WIG process with additive material, see figure 5.4.

Figure 5.4. Welding repair of samples [31, 33]

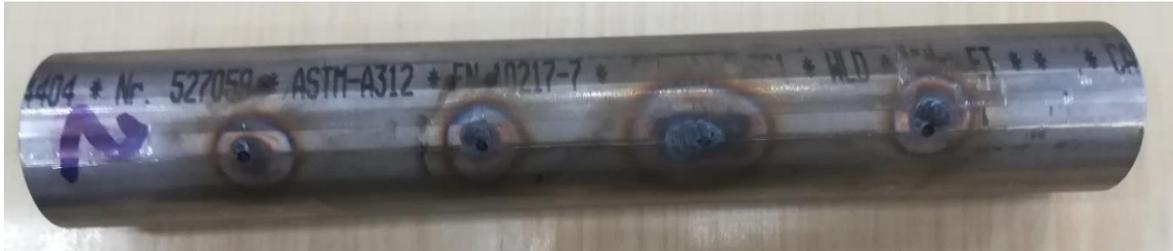
Figure 5.6. Sample 2 – 3 mm diameter holes

The samples obtained are presented in the figures 5.5÷ 5.9 [32].

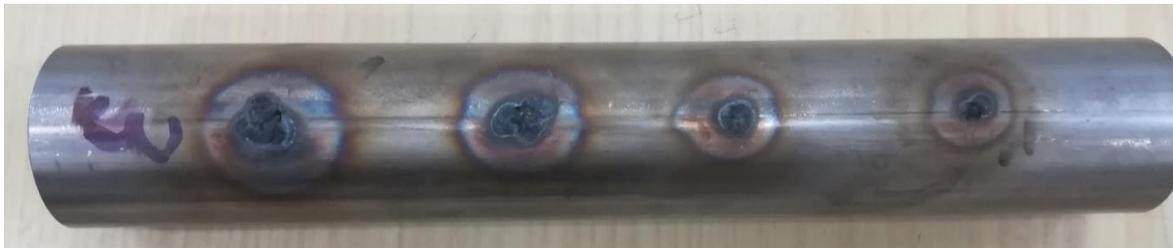
Figure 5.7. Sample 3 – 4 mm diameter holes

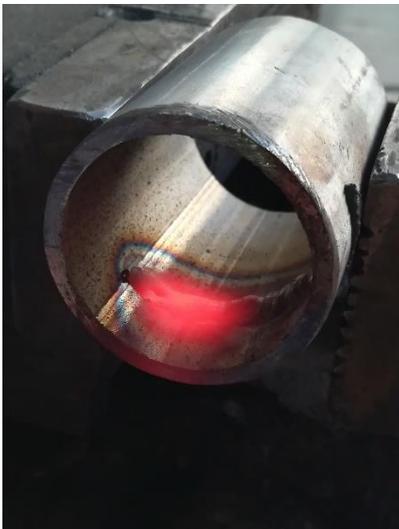
Figure 5.8. Sample 5 – linear defect on the circumference

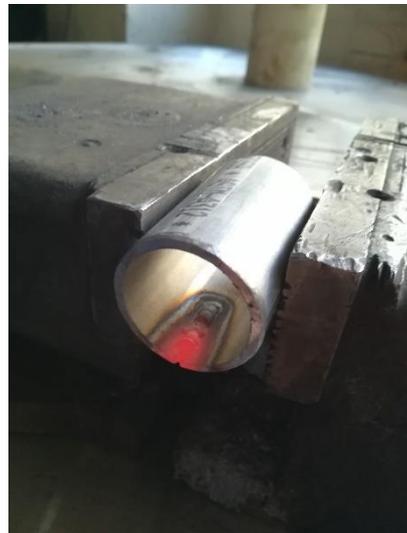
Figure 5.9. Sample 4 – linear defect along the length of the pipe

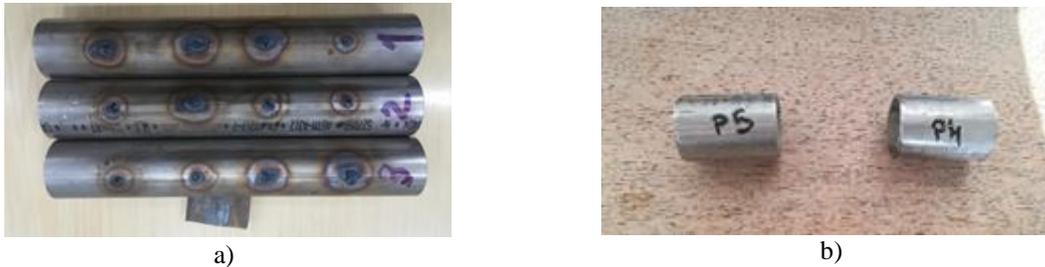
1. Sample cleaning - chemical cleaning was performed by degreasing - degreaser PFINDER890;

Figure 6.2. Sample cleaning,
a) Sample 1÷3 – circular defects, b) Samples 4 and 5 - linear defects

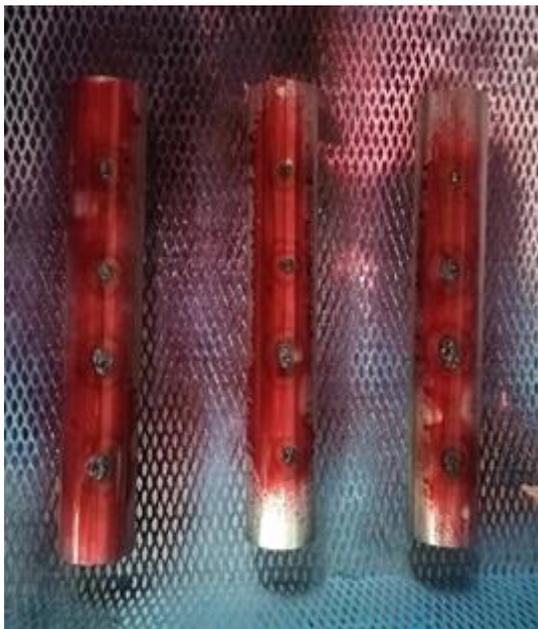
Figure 6.3. Penetrant application - samples 1÷3

2. The surface drying was forced using a hot air jet;
3. The application of the penetrant was made by spraying on the surface from a distance of about 10 cm, the penetration time used: 10 min; sample 4 and sample 5 were also examined inside (figure 6.3, respectively figure 6.4);

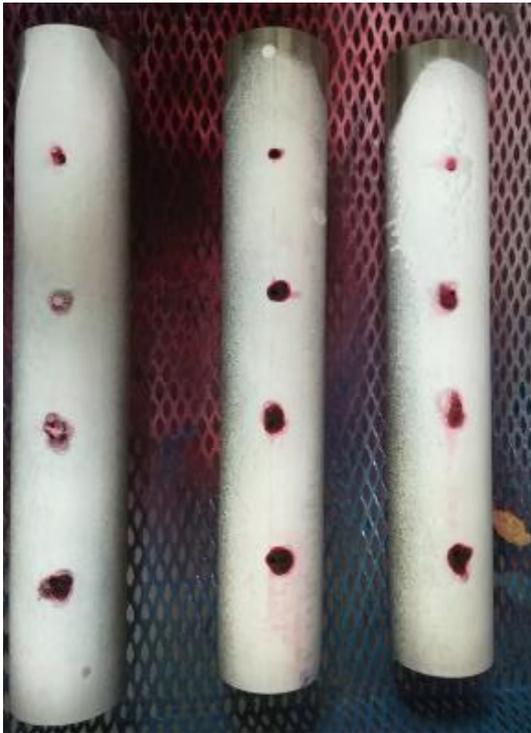
Figure 6.5. Developer application samples 1÷3

4. Excess penetrant removal - was done by washing;
5. Surface drying - was done using a hot air jet;
6. Developer application - see figure 6.5, respectively 6.6
 - ✓ the developer was applied in a uniform and thin layer, on the entire surface to be examined, being well agitated before use;
 - ✓ after being applied to the developer, the examined surface was allowed to dry at room temperature; the development duration started immediately after the surface dried, the time being 20 min.

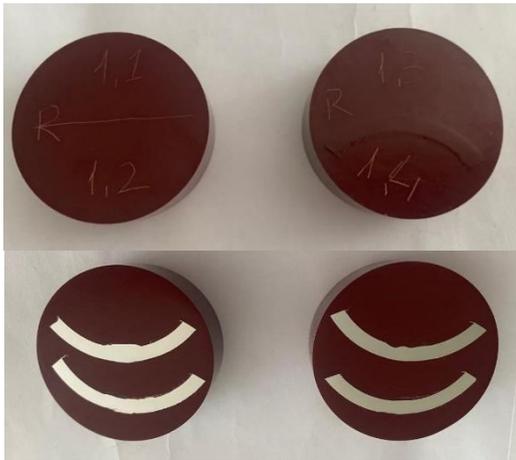
Figure 6.8. Sample 1 – positioning of welding points [33], 1.1. – point 1 - 50 mm; 1.2 – point 2 - 100m; 1.3. – point 3 - 150 mm; 1.4 - point 4 - 200 mm [33]

- ✓ The incorporation of the samples was done in phenolic resin;
- ✓ Manual polishing of the samples using abrasive discs with a grain size of 360, 500 and 1000 and Topol 3 solution. The samples were chemically treated using royal water consisting of 3 parts HCl and one part HNO₃. The samples are shown in Figures 6.8 and 6.9.

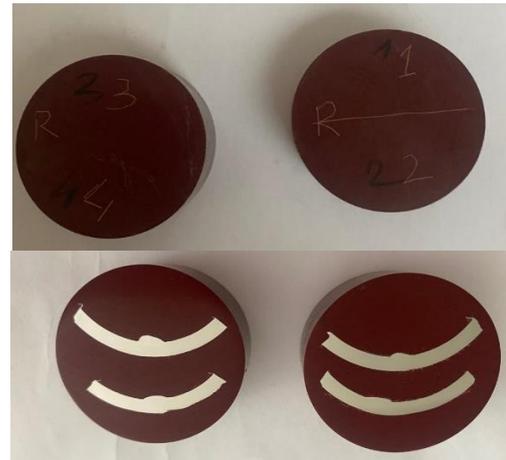
Figure 6.9. Sample 2 - positioning of welding points [33], 2.1. - point 1 - 50 mm; 2.2 - point 2 - 100m; 2.3. - point 3 - 150 mm; 2.4 - point 4 - 200 mm [33]

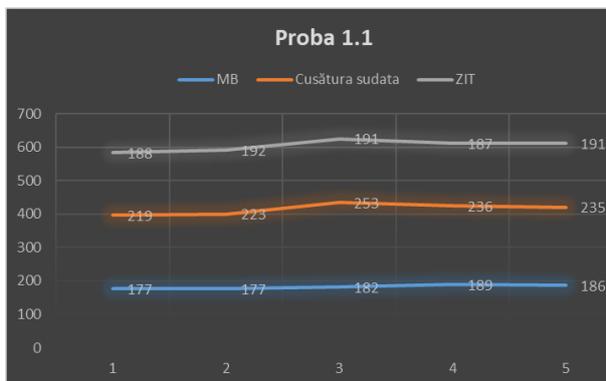
Figure 6.24. Hardness values graph for sample 1.1 [32]

The determination of the material hardness was performed using the Shimadzu HMV 2T micro hardness tester, the pressing force of 4.903N, the test time of 10 seconds, and 5 successive measurements were performed, in line, on the characteristic areas with distances of about 500µm between fingerprints. The hardness values measured for the first two samples are centralized in table 6.3., and the representative graphs are presented in figures 6.24 ÷ 6.25 [32].
