**University POLITEHNICA OF BUCHAREST
Faculty of ELECTRICAL ENGINEERING
Doctoral School of ELECTRICAL ENGINEERING**

**RESEARCH ON INCREASING EFFICIENCY OF DEFECT DIAGNOSE
IN CABLE ELECTRIC LINES**

SUMMARY

PhD Student: Eng. Marius-Florian PREDUȘ

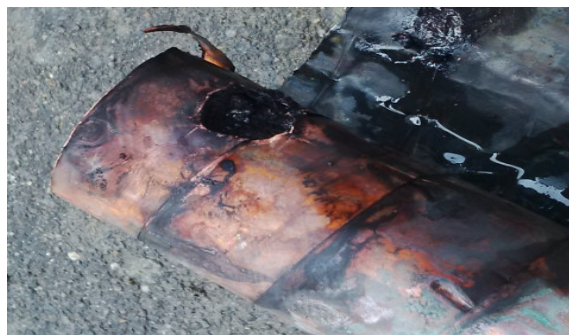
Fig.1. Irreversible partial discharge followed by breakdown of a medium voltage cable [16]

In practice, the breakdown phenomenon is preceded by a pre-discharge, in which the avalanche of electrons moves towards the electrodes generating a conduction current, and the electric discharge phase that leads in time to the breakdown. In most cases, the electric discharge is manifested only on a small portion of the dielectric (Fig.1), a situation in which the expression "partial discharge" is frequently used..

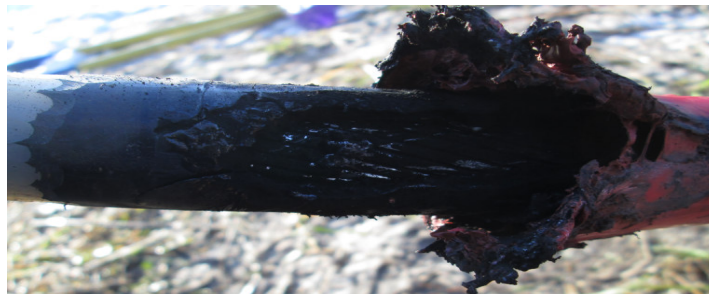
Fig.3. Insulation breakdown in the terminal head area [16]

Any breakdown of an electrical nature is followed by a thermal one, so it is difficult to separate the two types of breakdowns. Fig.3 shows an example of breakdown (combined) of the insulation of a medium voltage cable, having the effect of melting the material under the influence of heat released by the Joule effect.

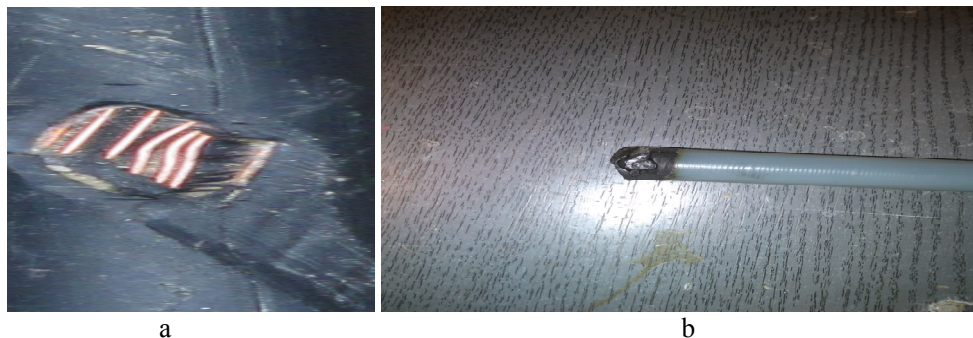
Fig.7. View of the insulation breakdown location :a) after removing the outer coating.
 b) after removing the semi-conducting layer

- In the absence of supply voltage, the internal temperature of the cable decreases with the temperature of the electrolyte in the tank, and the process of degradation of insulation is accentuated, because the insulation absorbs more electrolyte from the tank, causing significant decreases in insulation resistance. When re-energizing, the cable insulation broke through the voltage value of 42kV (Fig. 7).

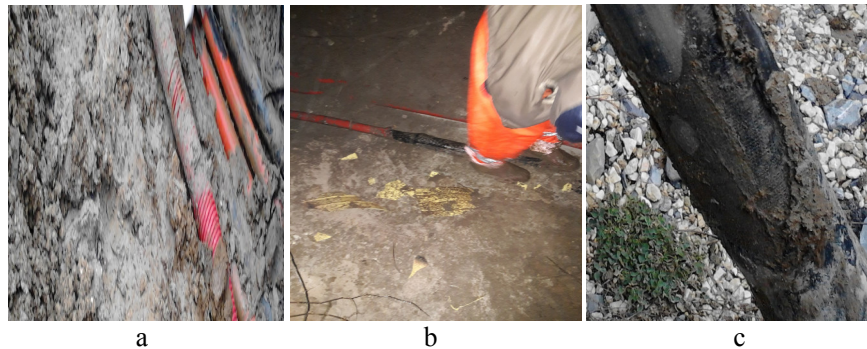
Fig.9.a),b). Identification of the sleeve defect on the solidified tailings portion c) The insulating (decomposed) portion of the heat-shrinkable sleeve resulting from the acid effect.

The corrosive substance formed by water with tailings acted aggressively on the insulation of the cables, especially in the area of the sleeves, affecting their operation (Fig.9).

The examination concluded that polyethylene (PE) is the most affected by the acidic environment, having a low chemical resistance to corrosive acids, while the insulation of HEPR (ethylene propylene rubber) and PVC (polyvinyl chloride) have a higher chemical resistance. high, protecting the electric cable from the effect of acid water.

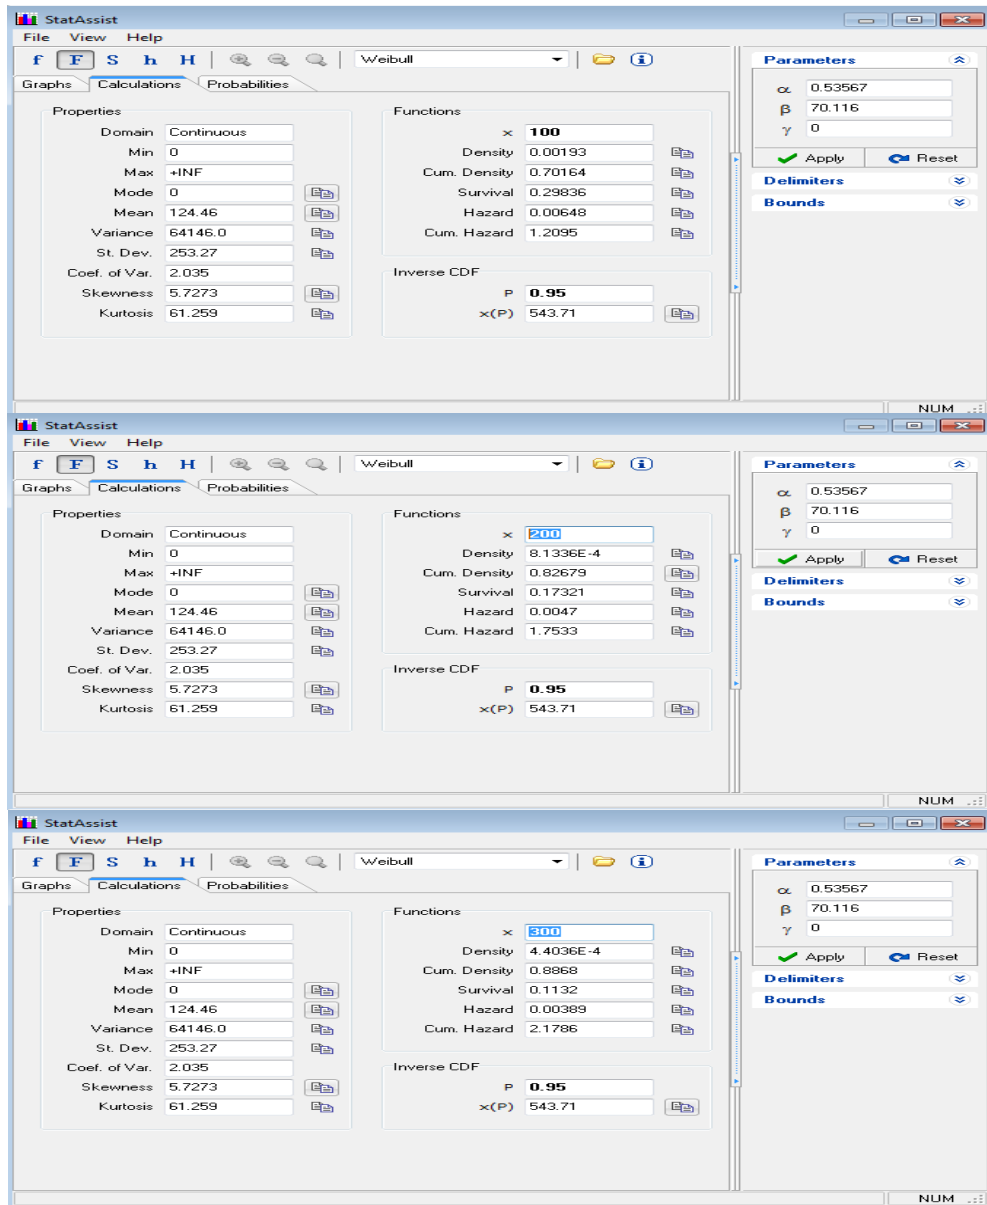
Fig.11. Percentage values calculated for intervals of 100, 200, 300 days

The percentage values calculated automatically are presented in Fig.11.

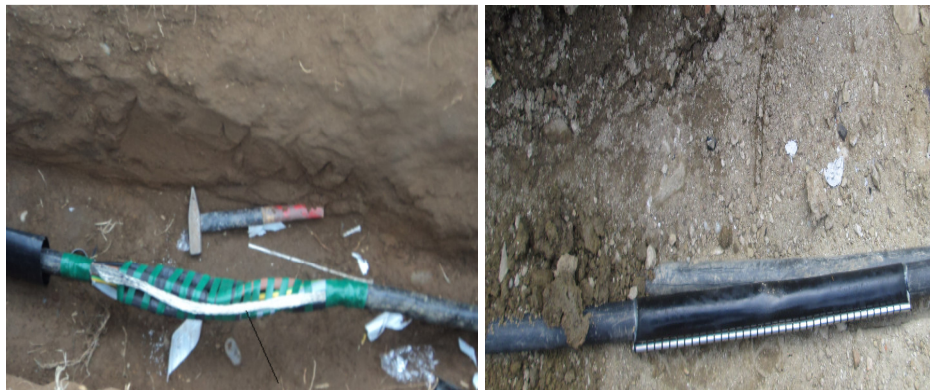
Fig.18. Installation of tinned braid with fixing rings for reinforcement transfer; Installation of the heat-shrinkable zipper sleeve

The excavation was performed next to the only sleeve identified on the cable section (Fig.18) and the outer sheath was sectioned to restore the continuity of the metal reinforcement, by mounting a tinned braid.

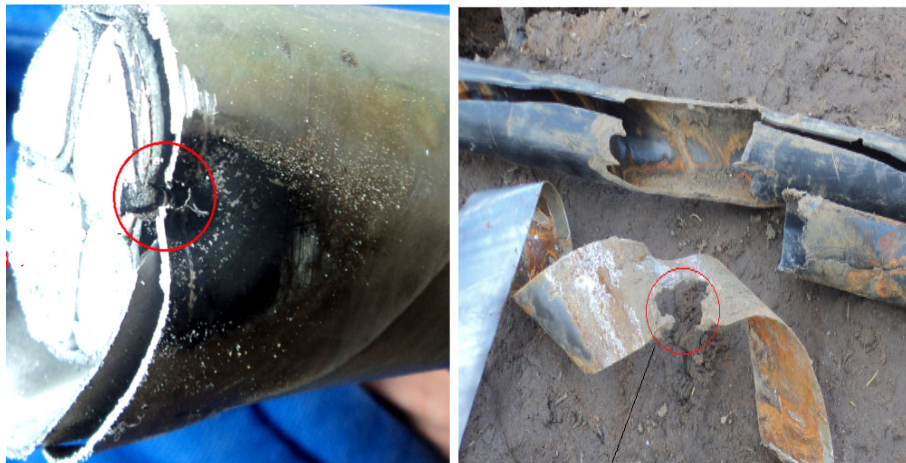
Fig.19. The point of insulation breakdown between the conductor and the metal reinforcement; The portion of the steel strip in which the electric arc generated the vibration phenomenon of the metal reinforcement.

After the excavation, the outer sheath of the cable was sectioned to visualize the defect and it was concluded that the noise of the sheath was produced by the vibration of the metal reinforcement, under the action of the electric arc created between the defective conductor (potential high) and the reinforcement (potential zero). which also produced a cavity in the steel strip of the reinforcement (Fig.19).

In conclusion, the detachment of the metal reinforcement from the earthing belt determined the attenuation of the mantle noise by changing the resistance of the defect, this time the electric arc being established between the defective conductor and the ground, the metal reinforcement being insulated from the ground.

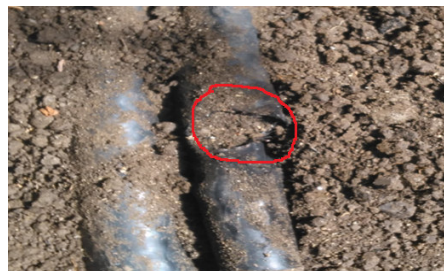
Fig.21. Visualization of the sleeve defect after the excavation

The cable was sectioned in the sleeve area for sleeve and the insulation resistances of the two resulting sections were measured, finding that on the starting section to the opposite end, respectively to the pole number 50, there is another defect.

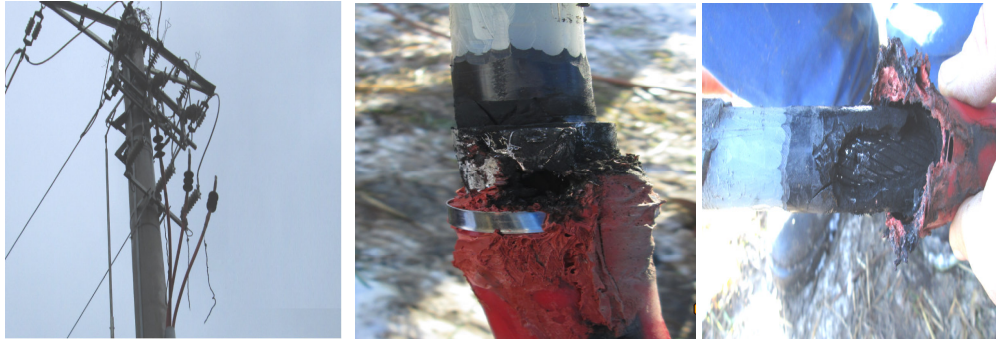
Fig.22. a) Detaching the copper shields from the earthing belt of the OHL pole and identifying the terminal head defect; b) Removing the outer shell and overviewing the defect.

The megohmmeter indicated the value of $2.5\text{ k}\Omega$. For this value, the IT pulses managed to generate an electric arc, the defect being identified inside the terminal head (Fig.22).

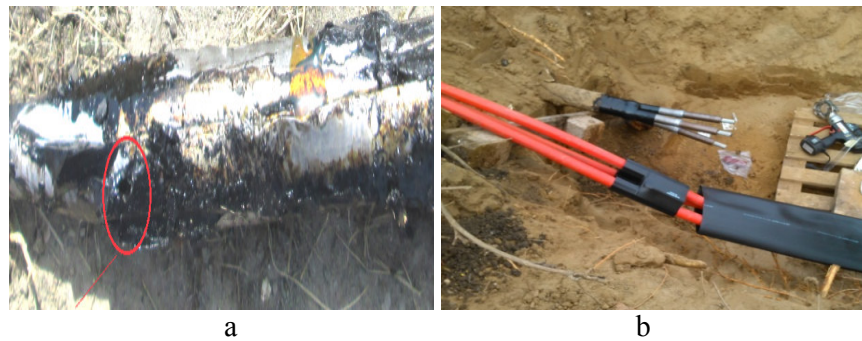
Fig.25 . a) Identification of the breakdown point in the cast iron jacket; **b)** Cable sleeve using two transition sleeves from HIU cable to three cables monopolar cables with XLPE insulation.

The excavation was carried out in the indicated place and a defect of piercing of the sleeve was discovered on a section of cable with oil insulation Fig.25.
