**UNIVERSITY “POLITEHNICA” of BUCHAREST**  
**FACULTY OF MATERIALS SCIENCE AND ENGINEERING**  
**Doctoral School of Materials Engineering**

## **SUMMARY**

### **EXPERTISE IN THE FIELD OF ECOSOCIOTECHNOLOGICAL DEGRADATION OF METALLIC MATERIALS**

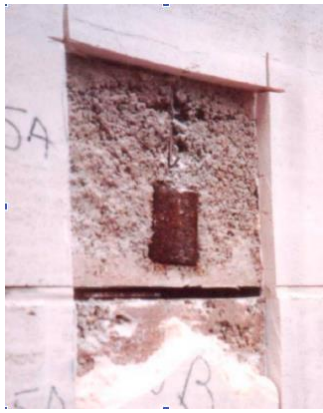
Corrosion of steel requires the simultaneous existence of moisture and oxygen. Common atmospheric factors that can lead to steel corrosion (Fig. 2.3) include temperature, humidity, rain, wind speed and solar radiation [77].

**Figure 2.3. Corrosion of steel anchor plate embedded in precast concrete wall [71].**

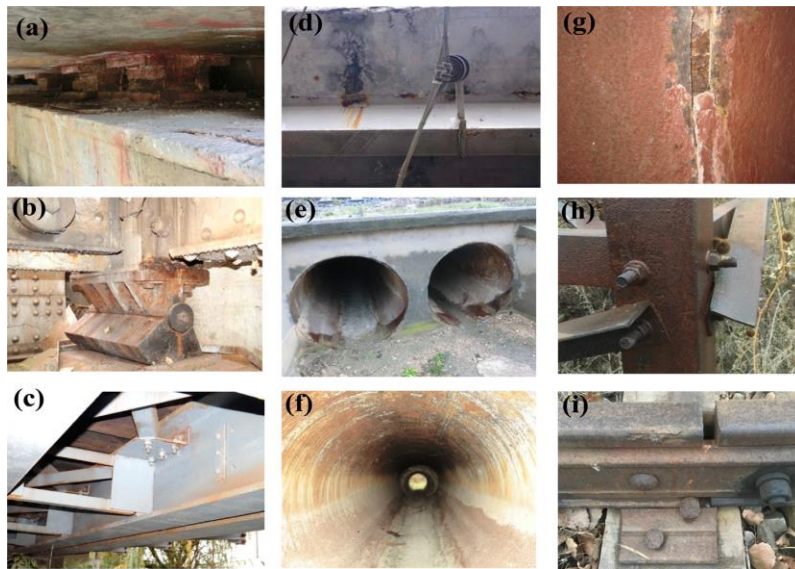
The most serious atmospheric corrosion of railway structures is present on track elements, catenary system and bridge structures. The most common examples of corrosion damage to such structures are shown in Fig. 2.5.

Figure 2. 5. Typical examples of corrosion defects in different parts of cast iron and steel railway structures exposed to the atmosphere: (a-d) supports, beams and bridge elements; (e-g) channel components; (h) catenary and (i) track elements [116].

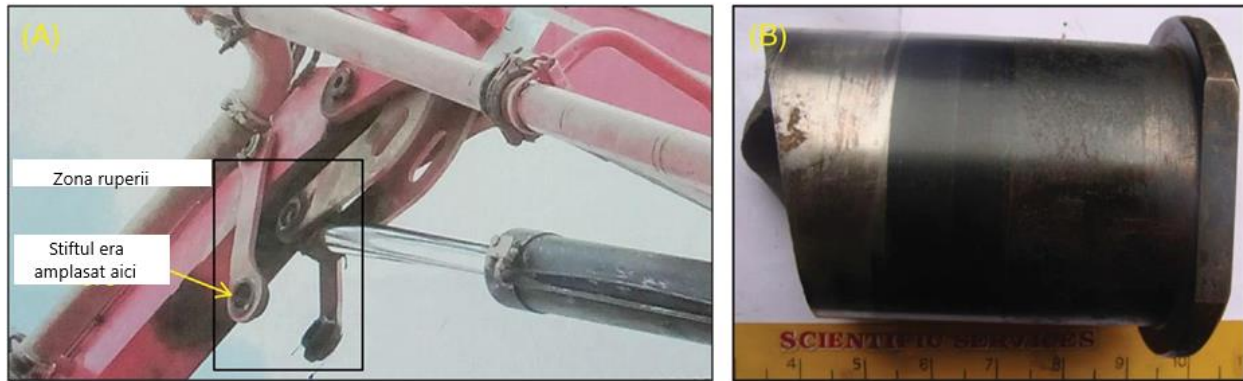
The styli failed during the construction of a building while the wet concrete mix was being poured high through a pipe using an arm placer. Fig. 2.16A shows the location of the failure on the arm where the stud was installed. The broken stud is shown in Fig. 2.16B.

Figure 2. 16. (A) Location of the arm pin failure at the arm setter, (B) defective arm pin [137].

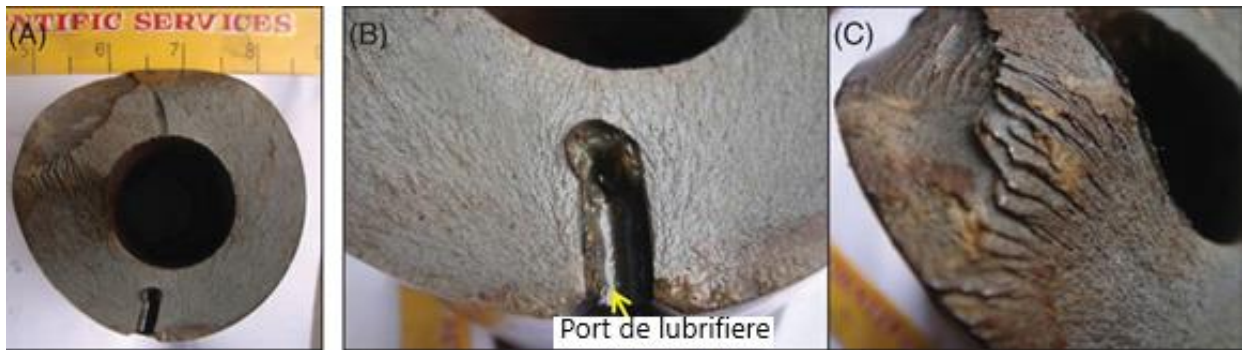
The failed stud was collected for investigation to find the root cause of the failure. The shiny granular flat surface of the fracture (Fig. 2.17) indicates the brittle mode of fracture. The fracture was initiated from a lubrication hole (Fig. 2.17B). Visual observation (Fig. 2.17A) shows that the pin was hollow cylindrical in shape, with an inside diameter of 40 and an outside diameter of 90 mm.

Figure 2.17. (A) Fracture surface of the arm pin, (B) initiation of chevron marks from the lubrication port indicating a brittle fracture, and (C) radial marks suggesting brittle fracture of the arm pin [137]

Structural analysis suggests that the pin fractured due to its low impact strength from improper heat treatment.

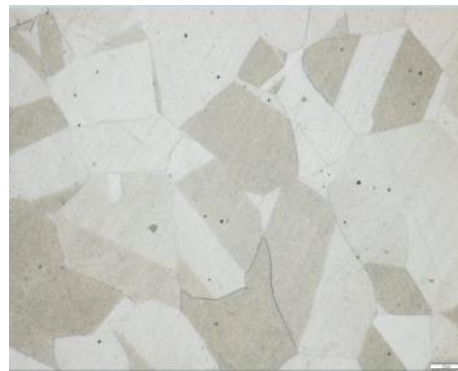
Metallographic analyses were carried out at UPB - ECOMET, on the Olympus metallographic optical microscope, model BX51M. In Fig. 5.4 show the microstructures of the analysed *samples*.

**Figure 5. 4 Microstructures of samples from the 120 S1H heat exchanger tubes. (chemical attack with Marble reagent; magnification  $\times 500$ ) a) shingle space 2; b) shingle space 4; c) shingle space 7; d) shingle space 9**

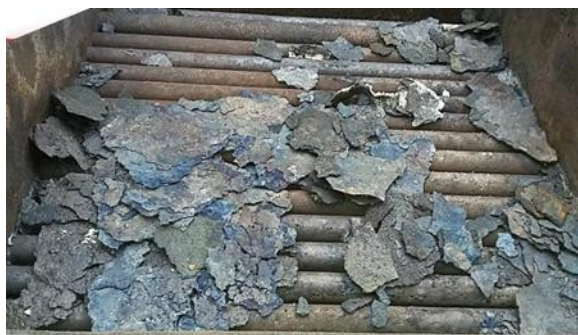
The adherent layers deposited on the pipe walls had a compact shape, fig. 5.5...fig. 5.8. The marking of the samples was done according to the positions of the spaces between the shims and the numbering was done starting from the entry connection into the space of the technological product.

**Figure 5. 5 Deposition of adherent substances on the pipe bundle of exchanger 120 S1H - general appearance**

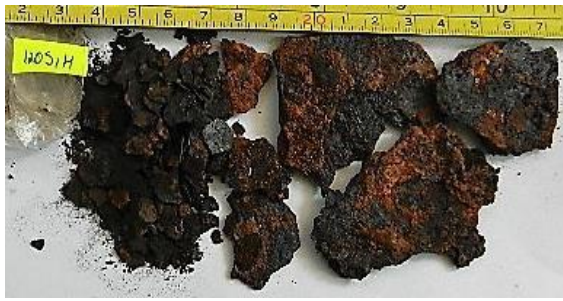
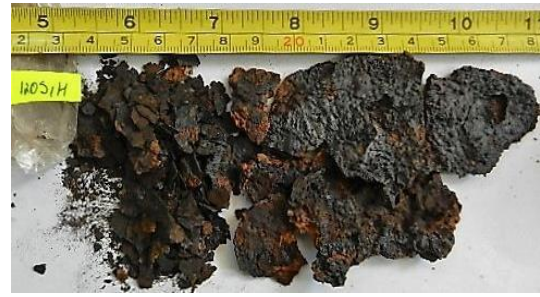
Figure 5. 6. Deposits in the zone of the shim 6. a) face 1 - front; b) face 2 - rear

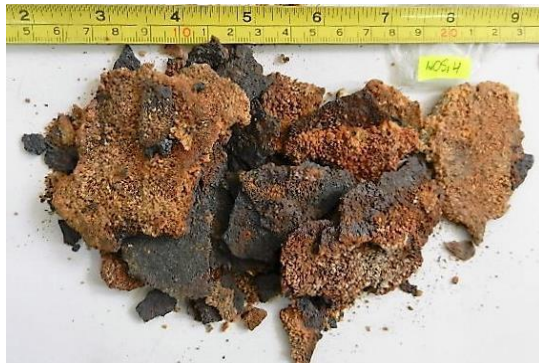
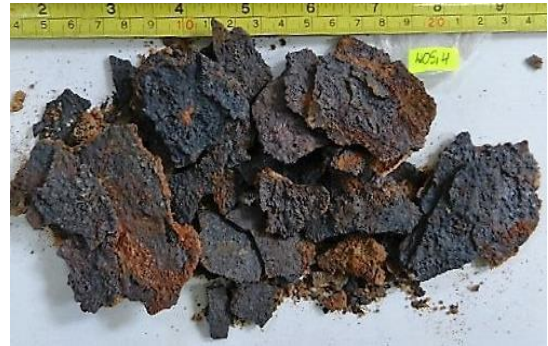
Figure 5.7 Deposits in the shear zone 7.a) face 1 - front; b) face 2 - rear

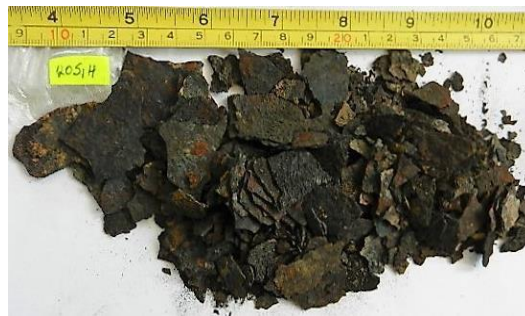
Figure 5. 8 Deposits in the chicanery area 8

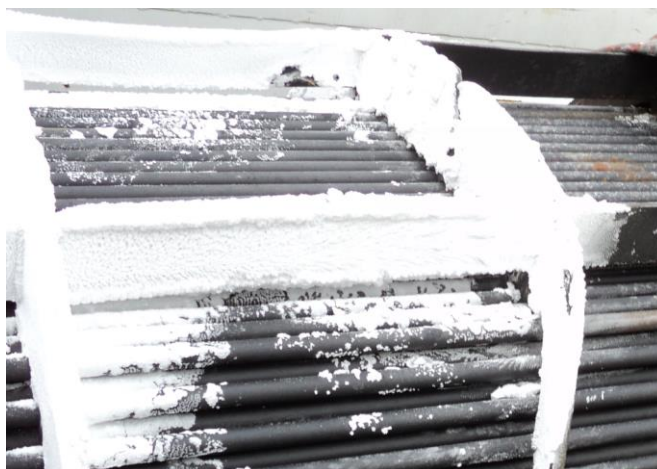
Case C refers to deposits identified on the surfaces of a heat exchanger in a hydrofinishing plant (Fig. 5.9). The process fluid contains sulphur compounds.

**Figure 5. 9 Macroscopic appearance of deposits formed on heat exchanger elements.**

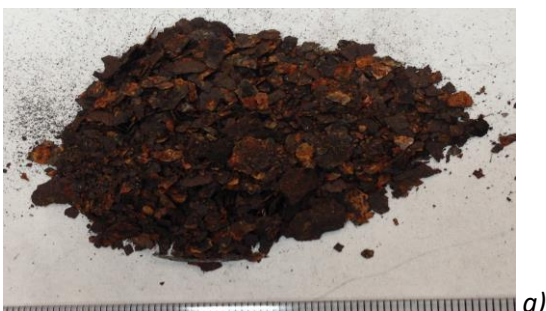
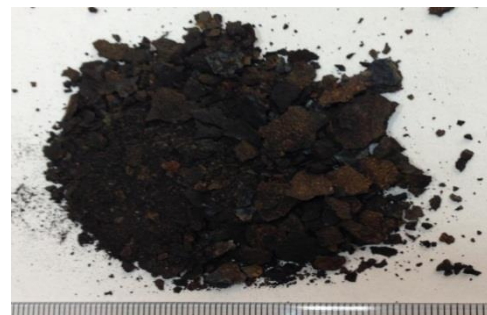
The macroscopic appearance of the corrosion products extracted from inside the pipeline is shown in Fig. 5.15.

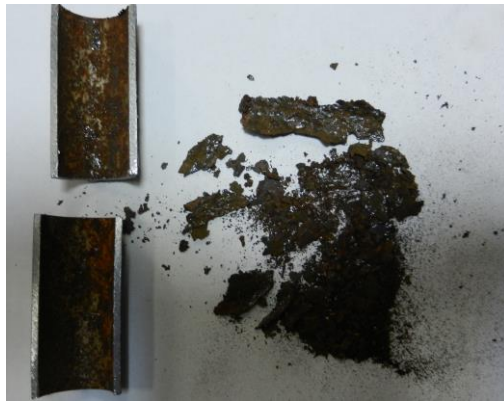
In the case of heat exchanger 120 S1, the risk of activation of the corrosion process is determined by the possibility of the formation of deposits of residues with a high water content, during the periods when the equipment is emptied for inspections or repairs, Fig. 5.18.

**Figure 5. 18 Residue deposits on the inner surfaces of heat exchanger tubes.**

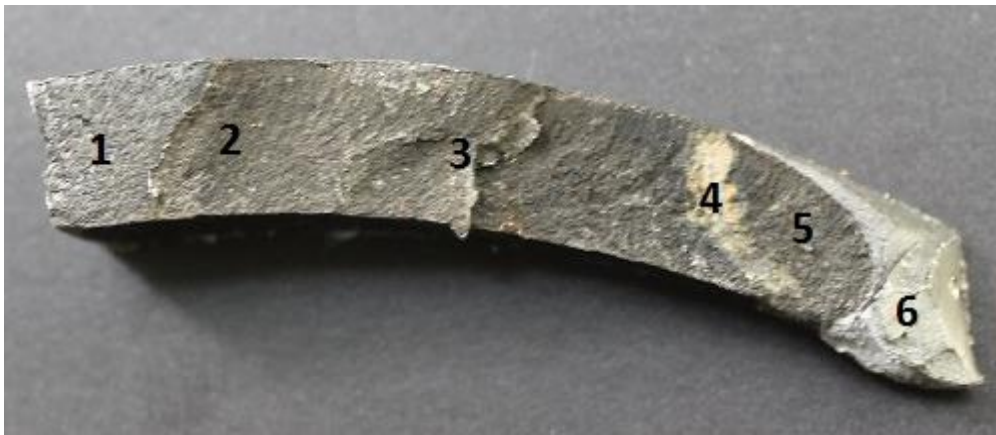
- adherent layers of residues were deposited on the inner walls as a result of the corrosion process;
- the pipes were stressed by the action of a thermomechanical stress oriented in the axial direction;
- a corrosion crack was present on the inner wall of a pipe, oriented perpendicular to the longitudinal direction of the pipe (Fig. 5.23).

**Figure 5.23 Macroscopic appearance of the surface of the cracked specimen (tube No. 51)**

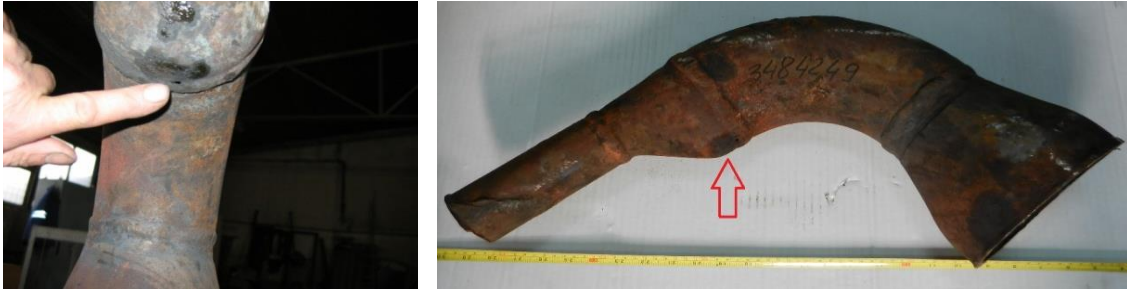
- on the inside, the surface of the pipes shows pronounced signs of general/extended corrosion and spot corrosion, including in the welded seam areas - fig. 5.30. The surface of the inner walls is covered with extensive dark deposits - fig. 5.31.

Figure 5. 30 Macroscopic appearance of the outer surfaces affected by the presence of pores due to corrosion (area of the DN 100/DN50 reduction made by welding - pipeline GH - 120-201)

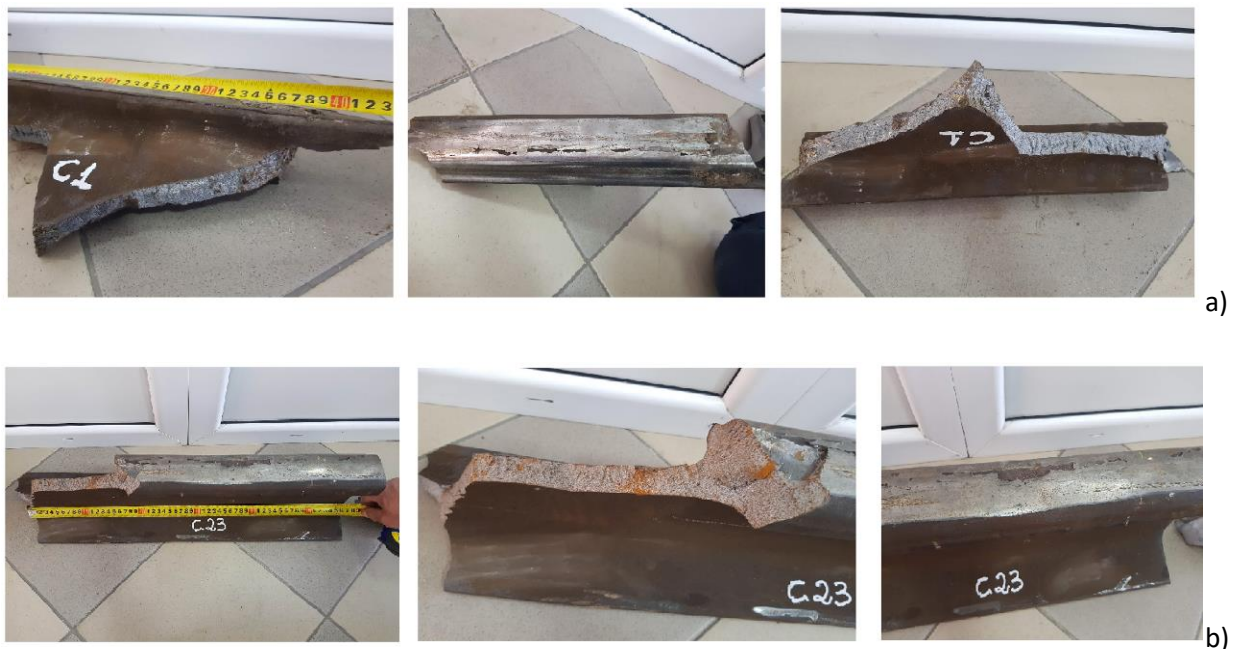
The macroscopic analyses were carried out on five samples taken from different samples of degraded rails (Fig. 5.39).

Figure 5. 39 Macroscopic appearance of degraded rail samples: a - sample C1; b - sample C23;
