**Contributions in the field of biomaterials used and
evaluation of the clinical functionality of metal implants
for fracture repair**

**~ ABSTRACT ~
PhD thesis**

**Contributions in the field of biomaterials used and evaluation of the clinical
functionality of metal implants for fracture repair**

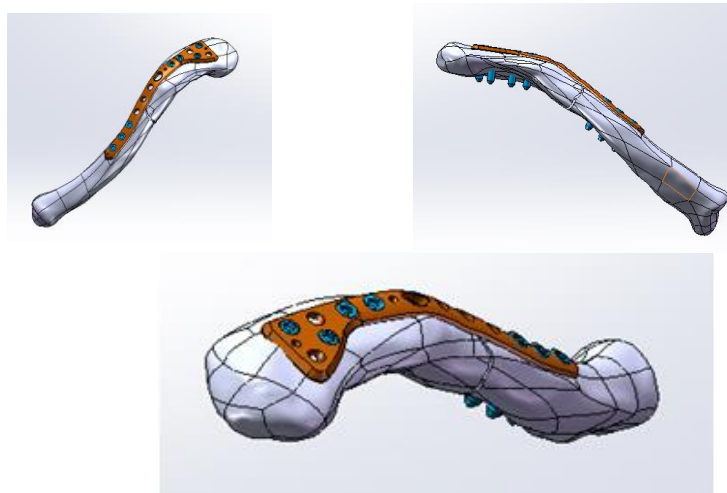
Due to the fact that the materials used in the case of osteosynthesis did not show material defects and the chemical composition complied with the material specifications, it was necessary to simulate the mechanical behavior of the stabilizing plate to identify possible causes that could have led to implant failure. Thus, the simulation of the board behavior was performed by Ansys 12.0 finite element analysis. The default simulation model for the screw plate was used in the analysis program (figure 4.7).

FIG. 4.7. Screw plate simulation model for humerus fractures

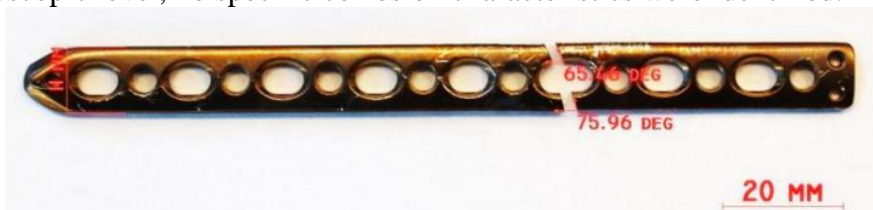
From the point of view of the general appearance of the implant surface, it can be seen that it shows pronounced marks of scratching around the rupture area of the implant (figure 4.11). These traces are due to the process of implant recovery performed with surgical devices. At the macroscopic level, no specific corrosion characteristics were identified.

FIG. 4.11 Macrography of the LCP type explant

It can also be seen in Figure 4.11 that the rupture of the implant at the 6th hole at the near end of the humerus occurred, apparently in a straight line, but which forms an angle of 76 degrees in relation to the longitudinal axis of the plate. On the right, respectively 65 degrees on the left [153].

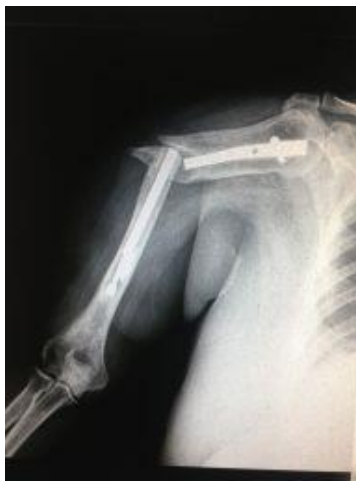
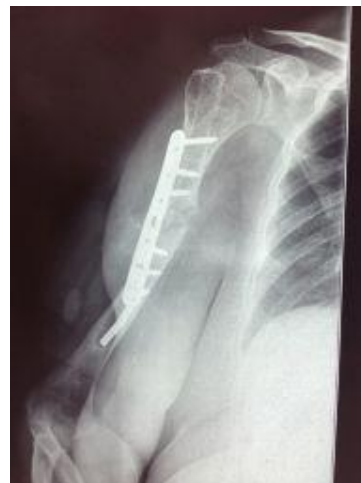
FIG. 4.2 0 CT images of the plate with screws a) after rupture b) after replacement of the osteosynthesis implant

Table 4.7 presents the clinical data of the patient according to the established protocol, and Figure 4.20 presents images of bone fracture obtained by conventional radiology.

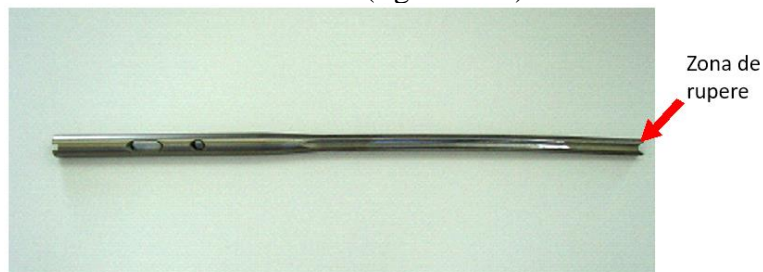
Following the macroscopic investigations, it is observed that the rupture of the centromedullary stem occurred at the distal locking system and at this level of investigation no scratches are observed on the implant surface (which could be made at the time of insertion in the human body) or excessive friction. screw (figure 4.26).

FIG. 4.26 Overview of the rod

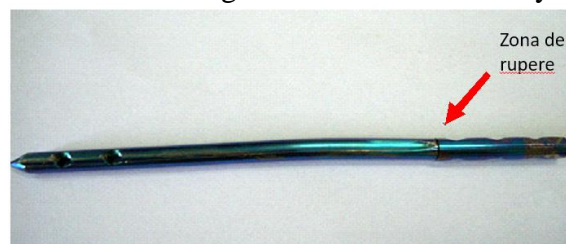
FIG. 4.32 Overview of the centromedullary rod

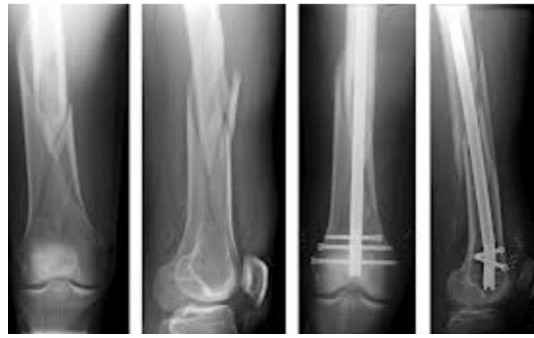
FIG. 4.37. Radiographs of the implanted area a, b) preoperative c, d) postoperative

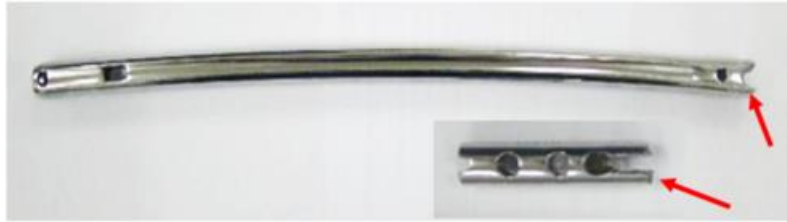
F fig. 4.44 TCF7 sample overview
