**Contribuții privind evaluarea biofuncționalității endoprotezelor de șoldmetal-metal tip BHR**

**Contributions on the evaluation of the biofunctionality of metal-metal hip endoprotheses type BHR**

## **Chapter 5. Analysis of Causes of Failure for Birmingham Hip Resurfacing (BHR) Hip Resurfacing Hip Endoprostheses Based on Investigation of Prosthetic Explants**

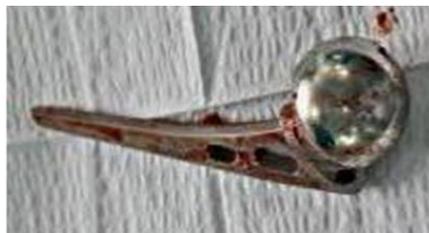
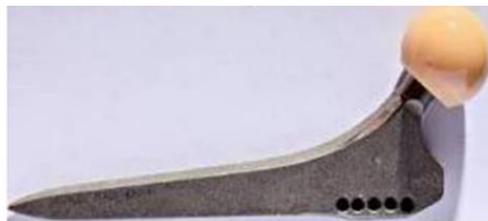
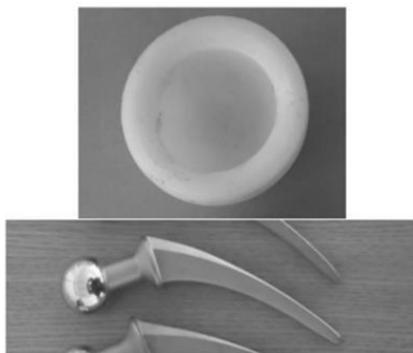
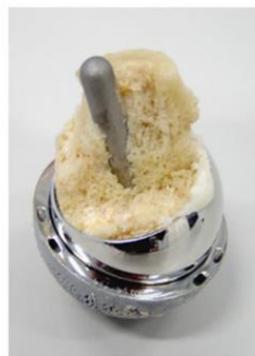
*Figure 18. Experimental samples used in the study of hip endoprosthesis explants*

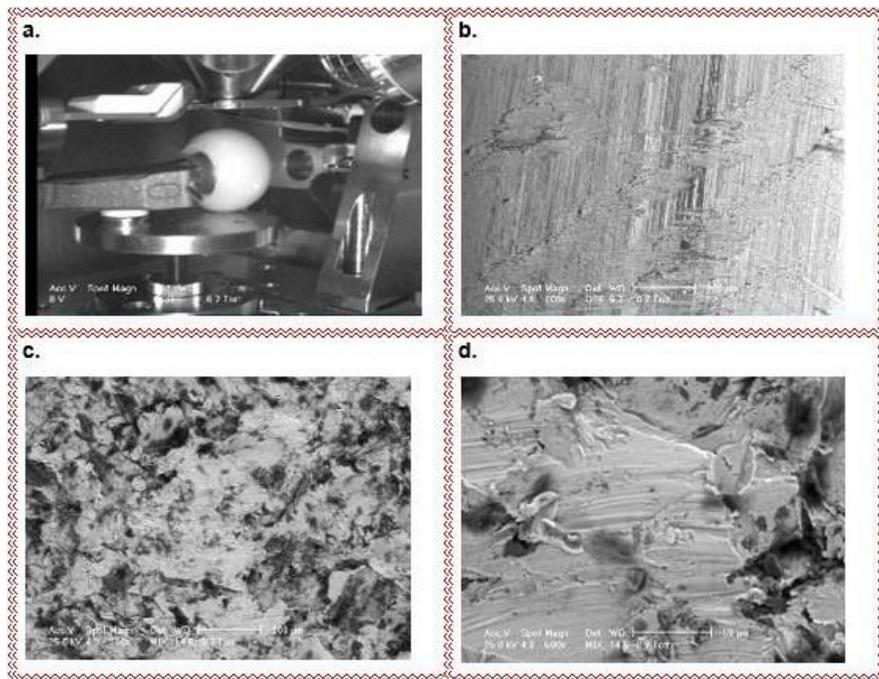
Figure 36. Image of the explanted prosthesis on the working table in the sample room of the scanning electron microscope: a,b,c,d. Scanning electron microscopy images of surfaces of interest

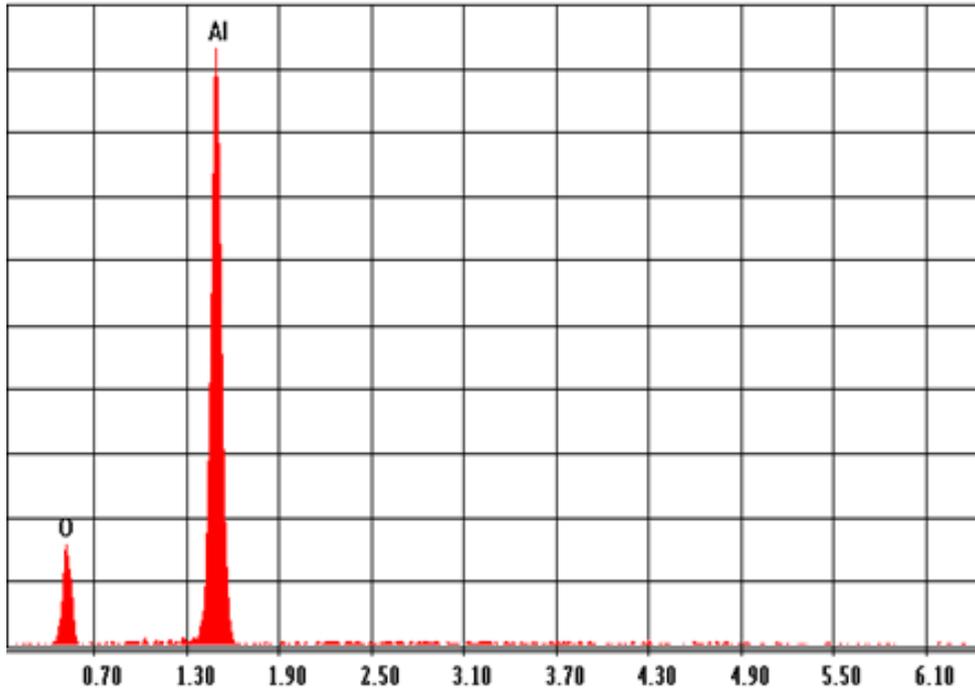
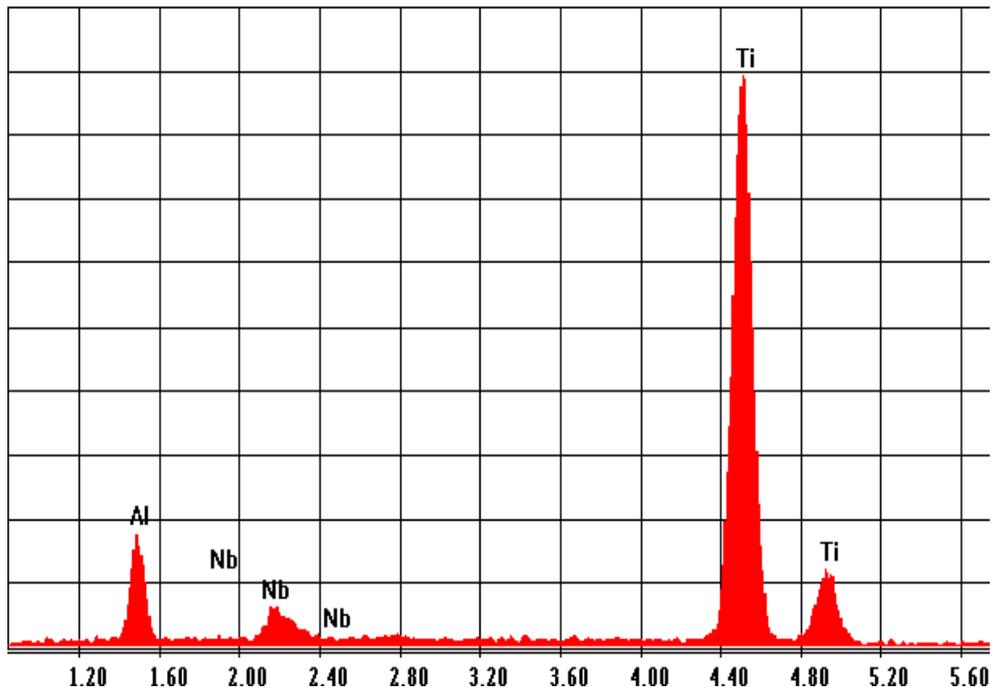
Figure 37. EDS analysis of the components of the hip prosthesis

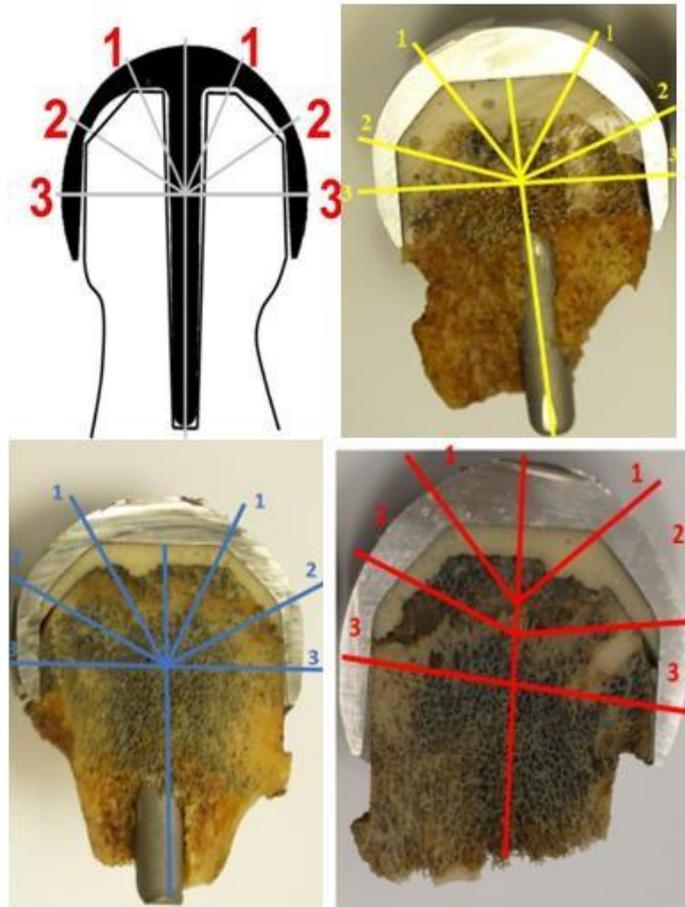
Figure 59. Contextual exemplification of the samples analyzed according to the reference model: Regions of interest for cement thickness and penetration analysis (1-3) <sup>18</sup>

In Table 8, we have calculated the parameters for this sample. The much too thick layers of cement are highlighted by the values of about 40 mm. We assume that the penetration of orthopedic cement into the bone is influenced by its low viscosity. By enlarging the image, in area three we notice gaps and metal debris that are visibly present.
